# Paint Stains Under Rappgard

**Section** Paint/Coatings

## Paint Stains Under Rappard

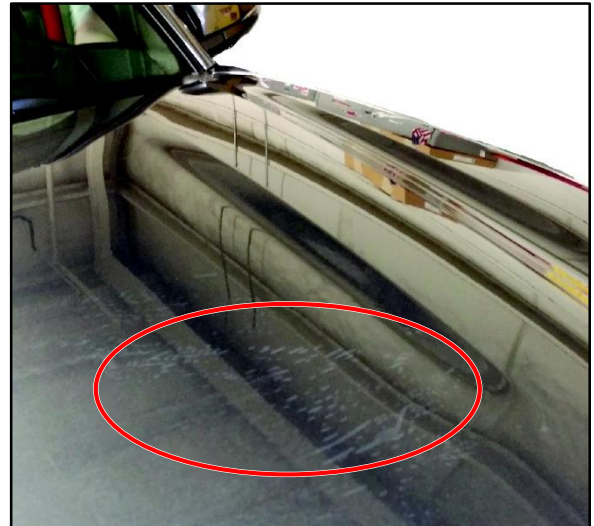
**Figure 1.**

Some 2010 – 2022 model year Toyota vehicles may exhibit paint stains after the removal of Rappard™. The paint stains may appear to be under the clear coat but are usually under wrinkles in the Rappard™. The wrinkles may trap water and cause the paint to stain from the trapped moisture, especially on horizontal surfaces such as the hood, roof, and trunk. Follow the Repair Procedure in this bulletin to address this condition.

1. Confirm the condition exists.  
 AFTER Rappgard™ removal, does the vehicle exhibit paint stains as shown?
  - **YES** — Continue to step 2.
  - **NO** — This bulletin does NOT apply. Continue diagnosis using the applicable Repair Manual.

2. Using aluminum foil or a damp cloth, cover ANY plastic and/or rubber parts located near the stain.

3. With an infrared lamp or heat gun, apply heat to the stain for 5 – 10 minutes at 158°F – 176°F (70°C – 80°C).

4. Wait AT LEAST 5 minutes AFTER heat application, then examine the area and determine if the stain has been removed.
