Depleted 12V Auxiliary Battery

Service Category Power Source/Network

YEAR(S)	MODEL(S)	ADDITIONAL INFORMATION
2021	RAV4 Prime

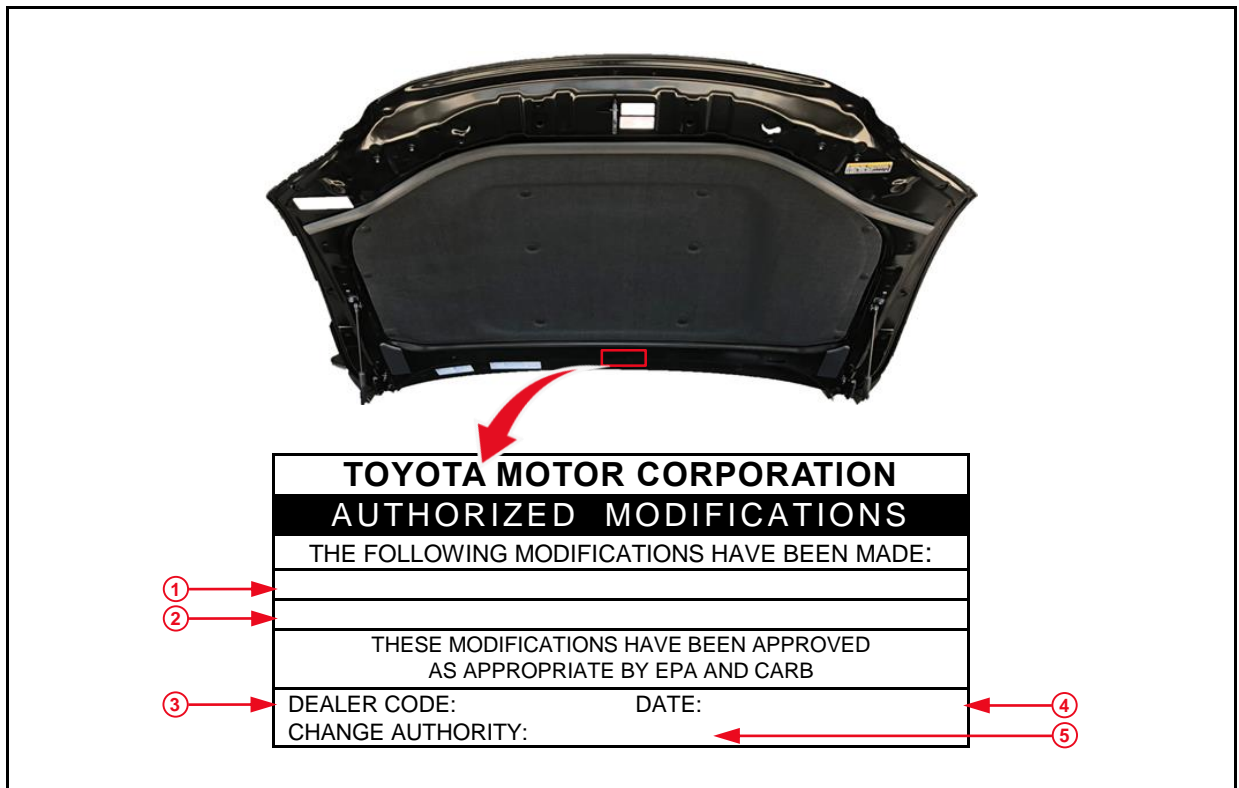
Figure 1. Location of Authorized Modifications Label on 2021 RAV4 Prime

- Use Techstream to confirm if the HV ECU calibration has been updated and check for the Authorized Modifications Label affixed to the vehicle in the location shown below.

- Prepare and install the Authorized Modifications Label.
 - Using a permanent marker, enter the following information on the label:
 - HV ECU part number [Refer to the **Parts Information** section for the **NEW PART NUMBER**]
 - Calibration ID(s) [Refer to the **Calibration Information** section for the **NEW CALIBRATION ID**]
 - Dealer Code
 - Repair Date
 - Change Authority [***This bulletin number***]
 - Install the Authorized Modifications Label onto the vehicle at the location shown in Figure 1. The Authorized Modifications Label is available through the MDC, P/N 00451-00001-LBL.
- Test-drive the vehicle to confirm proper operation.
