Rear Window Glass Run Pulled out of Position at Lower Rear Corner of the Back Window

2022 Tundra/Tundra-HV

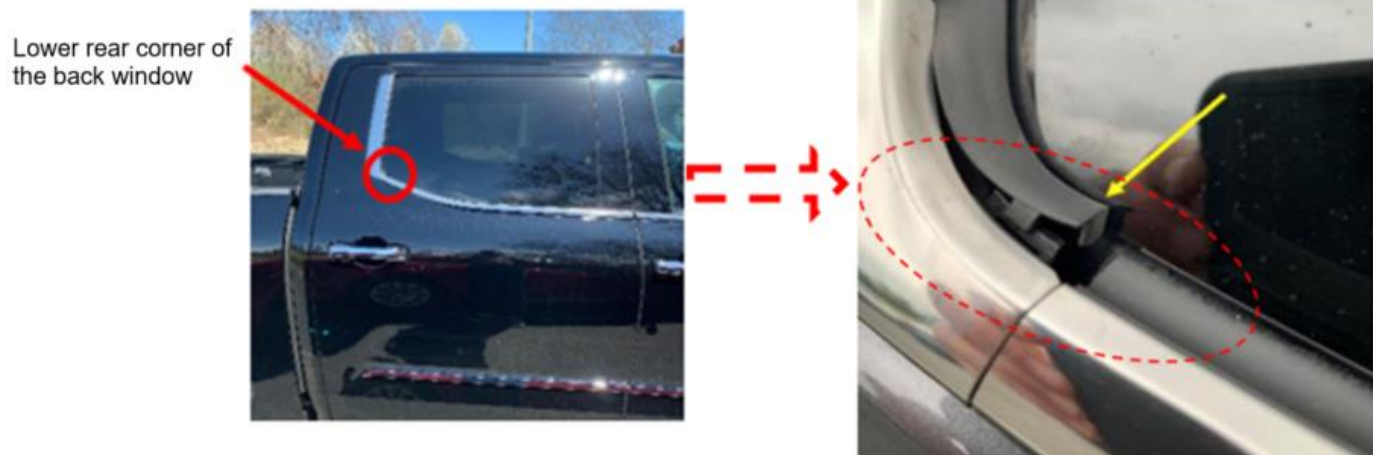
(Figure. 1)

Customers may experience a rear window glass run moulding that is not properly engaged. The glass run moulding may appear to be lifting, or pulled out of position, around the lower rear corner of the back window. Some customers may press downward on the moulding to re-secure it to rear door window frame, but it can lift again.

Re-assemble the rear door glass run moulding by following the repair manual instructions listed in the link references below.

Note: This condition may happen again if the J-Hook blocking tabs are not fully seated during glass run moulding reassembly. Make sure to confirm that all blocking tabs are fully engaged.

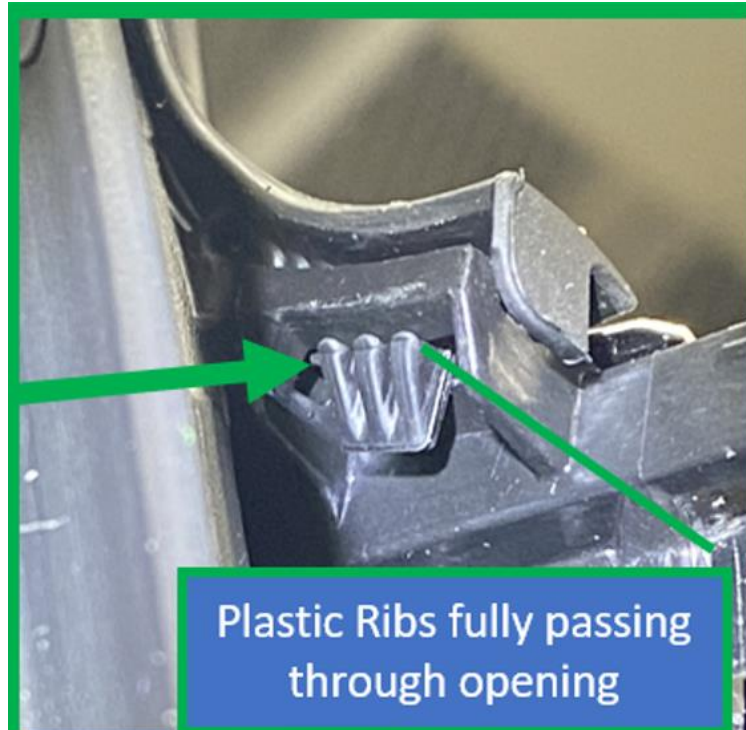
(Figure. 2)

J-Hook Blocking tabs – How to inspect

NOTE: Figure (2) captured with no inner door panel installed.

It is recommended to perform a visual check after installation to confirm all blocking tabs on J-hook are fully engaged.
