DTC U010087 & No Start/ Replaced Engine ECU After Jump Starting

USA

A25A-FXS

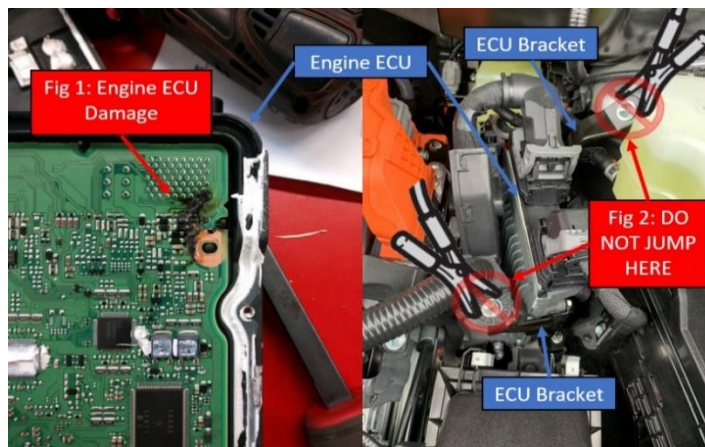
After jump-starting, the vehicle may experience a no-start condition and multiple DTCs including U010087. Upon investigation, it is found that the engine ECU has been damaged and needs to be replaced (Fig 1). In several cases, it was found that the cause of the ECU damage was improper jump starting. Further investigation found that ECU damage may occur if the jumper cables are hooked up on or around the engine ECU or ECU mounting bracket (Fig 2).

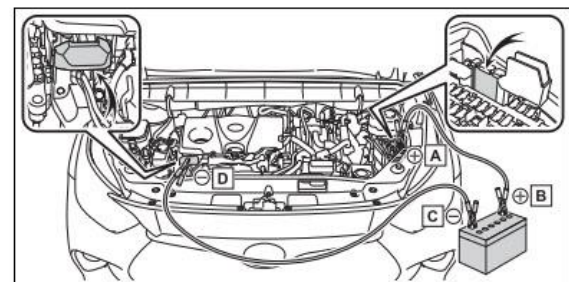
- [A] Exclusive jump starting terminal (your vehicle)
- [B] Positive (+) battery terminal (second vehicle)
- [C] Negative (-) battery terminal (second vehicle)
- [D] Solid, stationary, unpainted metallic point away from the exclusive jump starting terminal and any moving parts as shown in the illustration

To prevent this condition from occurring, it is recommended that the jumper cables be attached as described in the owner's manual. Below is an example of the correct jump start locations for 22 MY Highlander HV (Fig 3). Please consult the appropriate owners or repair manual to confirm the correct jump start location on other models.
