MIL ON With DTC(s) P0D2A19, P1C1B00, P0E8919, and/or P1BD300 and Inoperative Onboard Plug-in Charger

Service

YEAR(S)	MODEL(S)	ADDITIONAL INFORMATION
2021 - 2022	RAV4 Prime

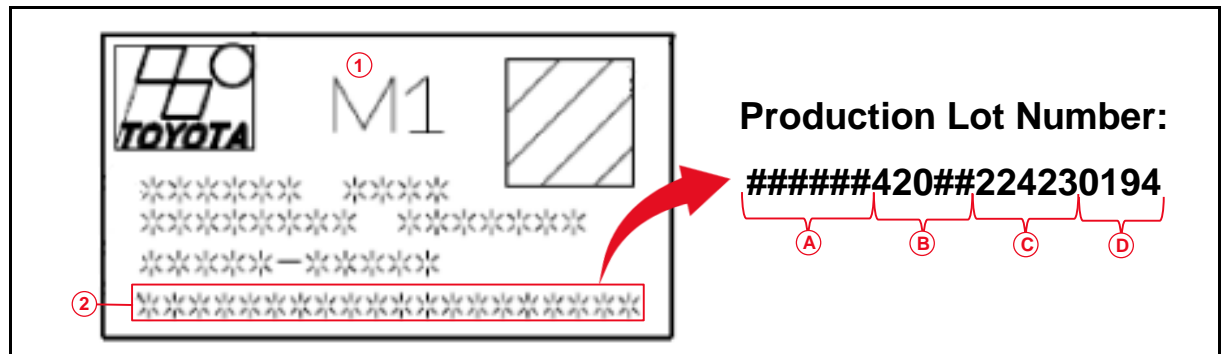
Figure 1. Label

2. Locate the electric vehicle charger sub-assembly in the vehicle and refer to the attached part label production lot number.
3. Confirm the vehicle is equipped with a 6.6 kW electric vehicle charger sub-assembly.

1	Label
2	Production Lot Number
A	Fixed Value
B	Last Five Digits of Part Number
C	Production Date (YYM*DD)
D	Consecutive Number

Are the last five digits of the part number listed on the label 42050, 42051, 42060, or 42061?

Are the last nine digits of the production lot number listed on the label less than 224230194?

5. Remove the electric vehicle charger sub-assembly.
Refer to TIS, applicable model and model year Repair Manual:
 - [2021](#) / [2022](#) RAV4 Prime:
Engine/Hybrid System – Hybrid/Battery Control System – “Hybrid / Battery Control: Electric Vehicle Charger Assembly: Removal”

6. Install the NEW electric vehicle charger sub-assembly.
Refer to TIS, applicable model and model year Repair Manual:
 - [2021 – 2022](#) RAV4 Prime:
Engine/Hybrid System – Hybrid/Battery Control System – “Hybrid / Battery Control: Electric Vehicle Charger Assembly: Installation”
