Rear Air Suspension Feels Rough Over Bumps

Service Category Suspension

Section Suspension Control System **Market** USA and Mexico

Some 2022 model year Tundra and Tundra Hybrid vehicles equipped with air suspension may exhibit a rough-ride feel when driving over uneven road conditions such as bumps or dips. Follow the Repair Procedure in this bulletin to address this condition.

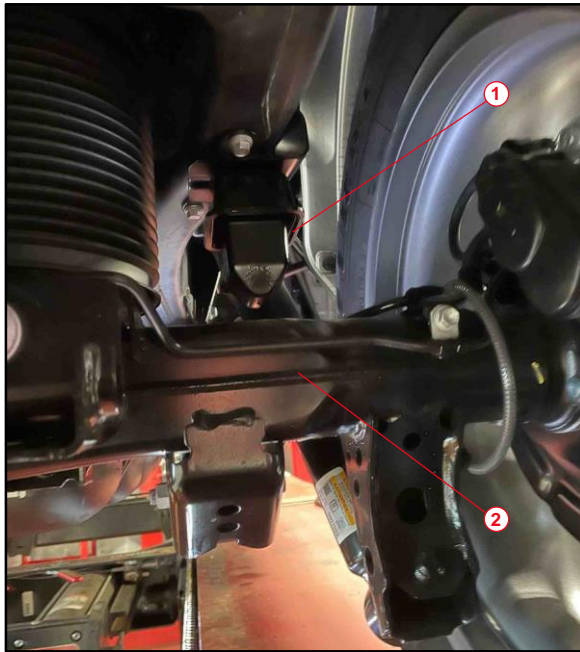
Figure 3.

- Under the vehicle, measure the distance between each rear bump stop and the top of the rear axle housing, as shown below.

1	Bump Stop
2	Rear Axle Housing

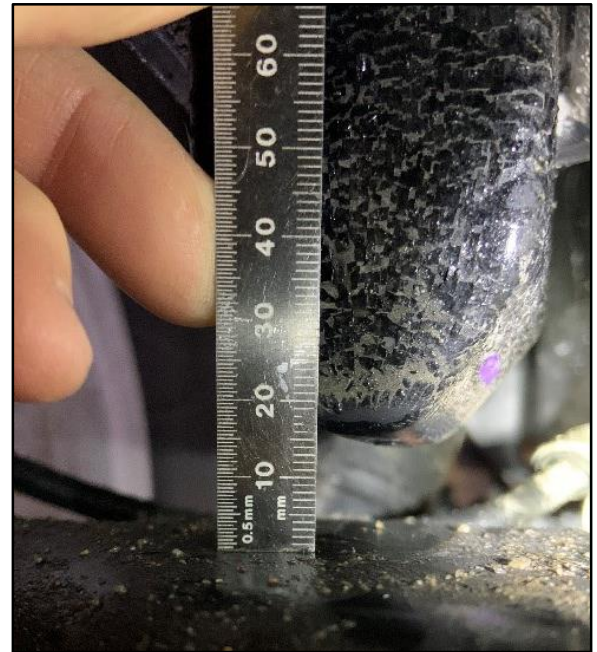
Figure 4. Bump Stop to Rear Axle Housing Gap

Is the gap less than 35 mm?

- YES** — Continue to step 6.
- NO** — This bulletin does NOT apply. Continue diagnosis using the applicable Repair Manual.

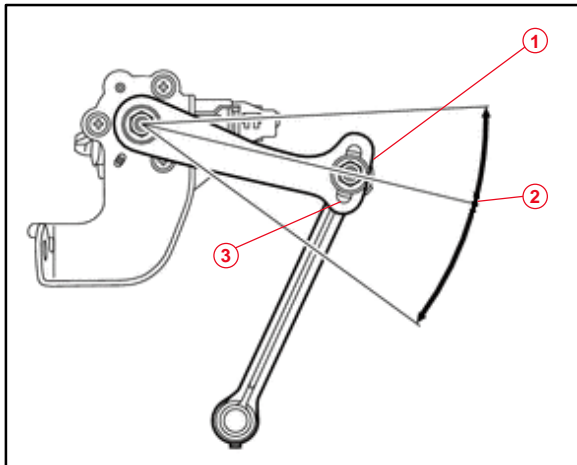
Figure 5. Nominal Factory Setting Versus New Target Setting

1	Nut (Loosen)
2	Factory Setting for Nut Position
3	New Target Setting for Nut Position

6. Adjust the height control sensor for each side.
 - A. Loosen the height control sensor nut.
 - B. Move the height control sensor link plate along the slotted hole of the bracket until it is positioned at the bottom of the slotted hole (see Figure 5).
 - C. Tighten and retorque the nut.

Torque: 5.6 N*m (57 kgf*cm, 50 in*lbf)
 - D. Repeat on the opposite side.

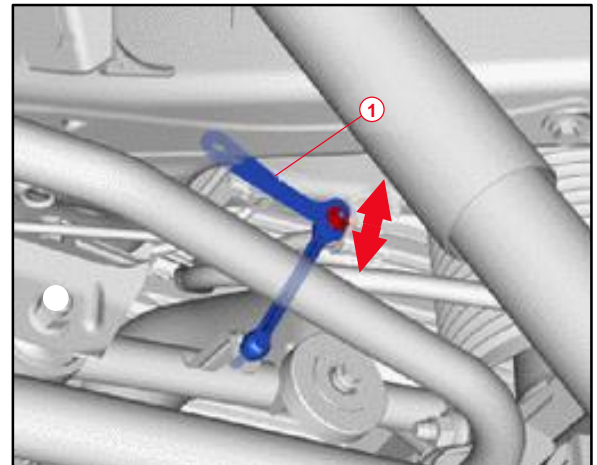
Figure 6.

1	Height Control Sensor Link Plate
----------	---

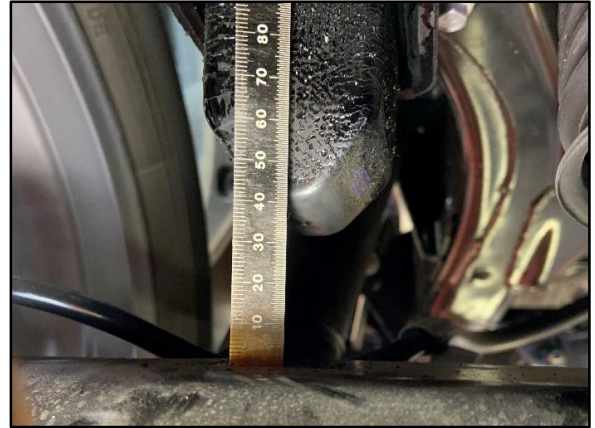
Figure 7. Bump Stop to Rear Axle Housing Gap

Is the gap measurement between 35 – 45 mm and equal side to side?

- **YES** — Continue to step 9.
- **NO** — Continue to adjust the height control sensors until an axle housing to bump stop gap of 35 – 45 mm is achieved. Then continue to step 9.

Do NOT exceed 45 mm.
