Subject		Market
2018-2022 GX460 Transfer Case Leak		USA
Service Category	Section	
Drivetrain	Transfer/4wd/Awd	
Applicability		
2018-2022 GX460

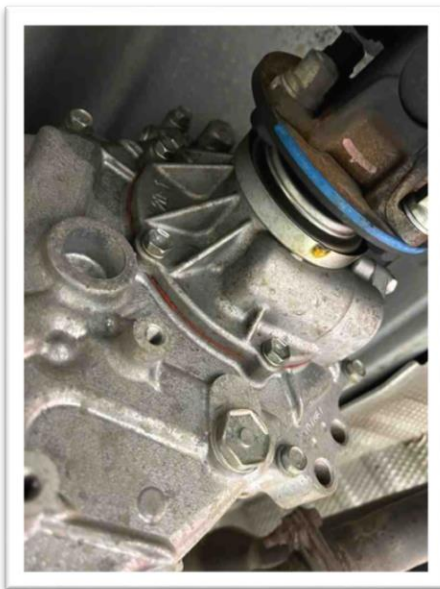
Oil may be found leaking from the transfer case input or rear output shaft seal as seen in the example pictures below:

Figure 1 Rear Output Shaft Seal Leak

If you see this condition, please create a TAS case and contact TAS for instruction prior to diagnosing or repairing of the vehicle. If it is a weekend or holiday, continue with diagnosis and repair. Please save all parts and/or details and contact TAS on the next available workday.

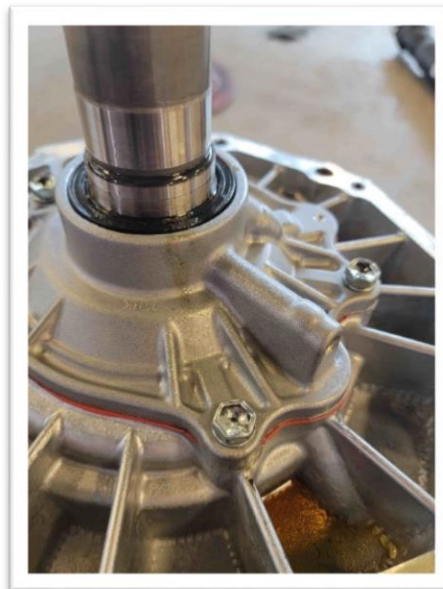
Figure 2 Input Shaft Seal Leak
