Subject 2018-2022 Tacoma/4Runner Transfer Case Leak		Market USA
Service Category Drivetrain	Section Transfer/4wd/Awd	
Applicability 2018-2022 Tacoma/4Runner

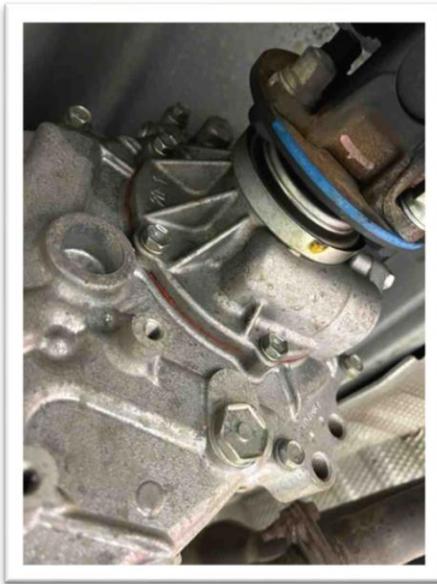
Oil may be found leaking from the transfer case input or rear output shaft seal as seen in the example pictures below:

Figure 1 Rear Output Shaft Seal Leak

If you see this condition, please create a TAS case and contact TAS for instruction prior to diagnosing or repairing of the vehicle. If it is a weekend or holiday, continue with diagnosis and repair. Please save all parts and/or details and contact TAS on the next available workday.

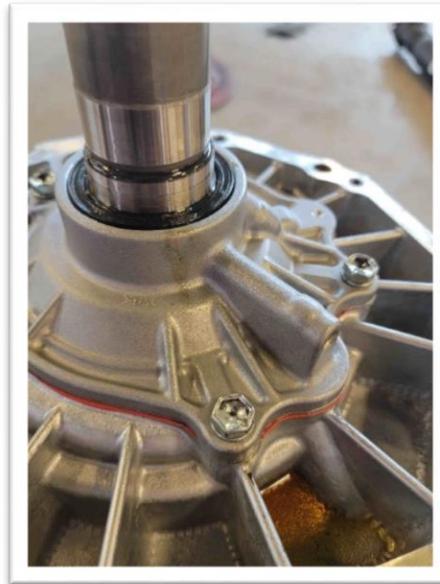
Figure 2 Input Shaft Seal Leak
