# Customer Satisfaction Program

## N212354520 Heated Vented Seats Retrofit Due to Chip Shortage - Front Seats Only

Release Date: September 2022

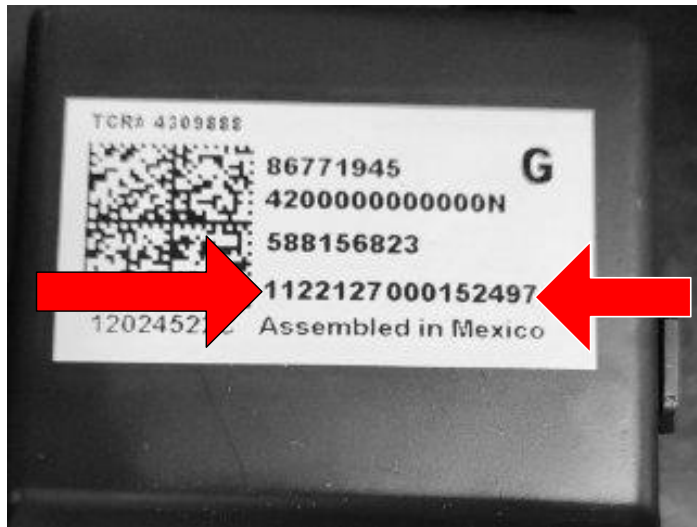
**Record the serial number on the front seat heater vent control module labels.**

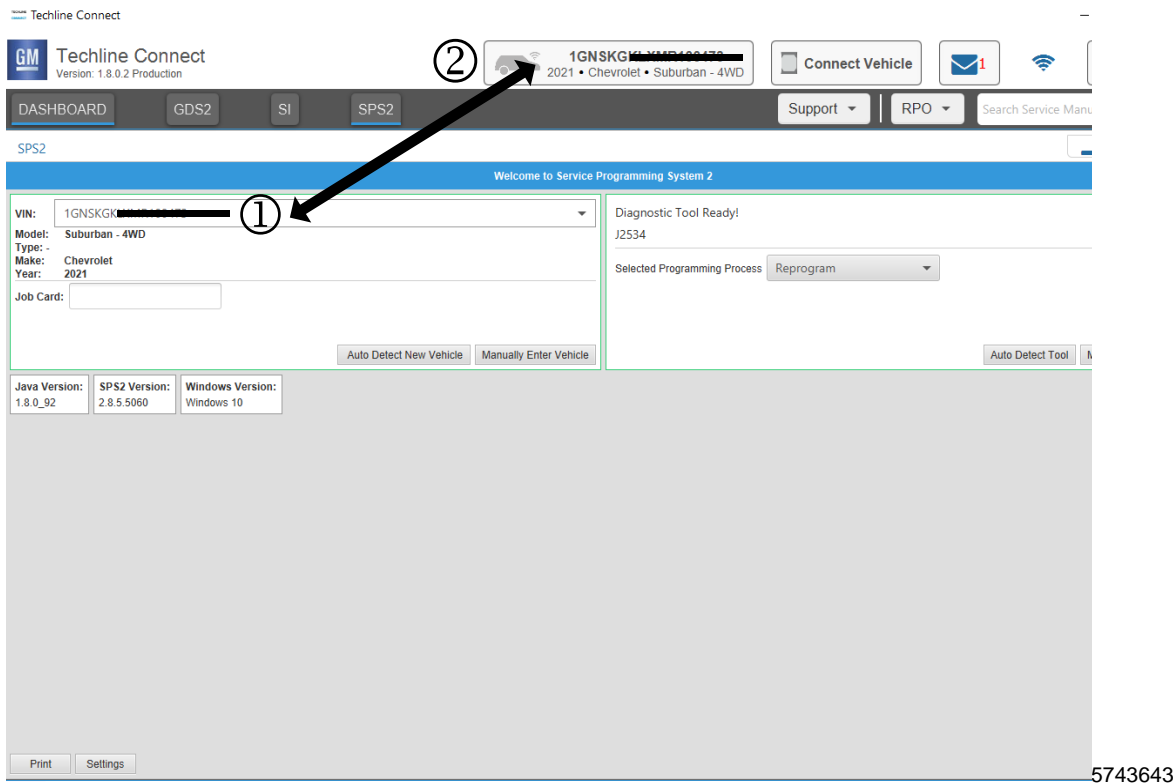
**Caution:** Be sure the VIN selected in the drop-down menu (1) is the same as the vehicle connected (2) before beginning programming.

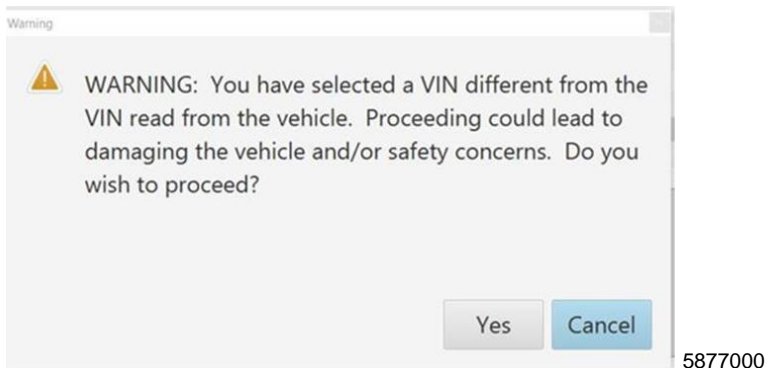
**Important:** If the vehicle VIN DOES NOT match, the message below will be shown.

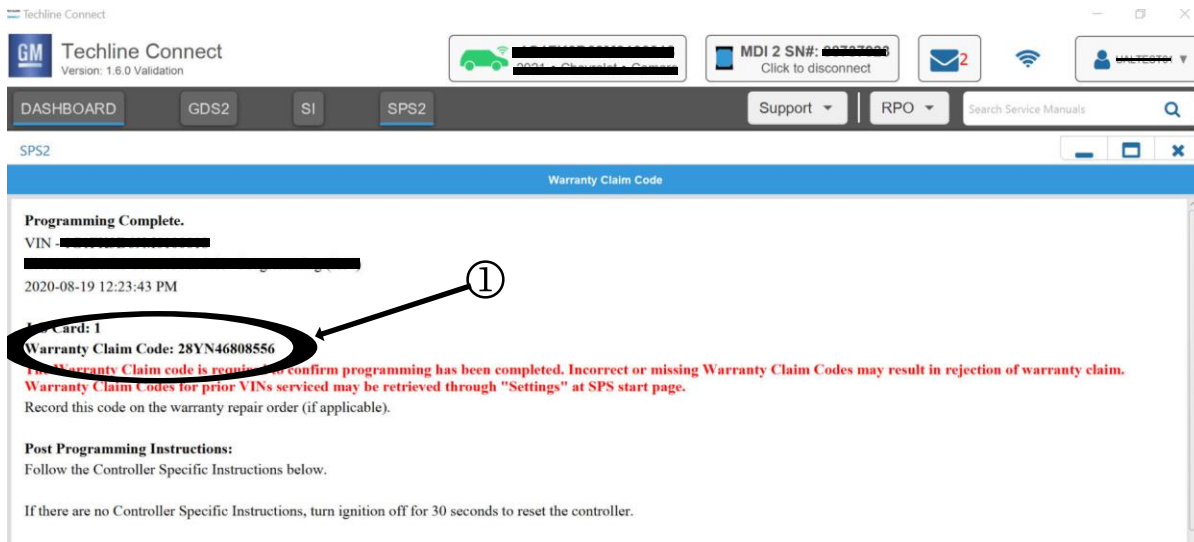
5644478

**Note:** The screenshot above is an example of module programming and may not be indicative of the specific module that is being programmed. Module selection and VIN information have been blacked out.

**Important:** To avoid warranty transaction rejections, you MUST record the warranty claim code provided on the Warranty Claim Code (WCC) screen shown above on the job card. Refer to callout 1 above for the location of the WCC on the screen.

5. Record SPS Warranty Claim Code on job card for warranty transaction submission.
