Service Bulletin

Bulletin No.: 21-NA-220

Subject: Loss of Power, Malfunction Indicator Lamp (MIL) Illuminated, Gauges Inoperative and/or Multiple Warning Lights/Messages Displayed on Driver Information Center (DIC) – Multiple DTCs Set

Brand:	Model:	Model Year:		VIN:		Engine:	Transmission:
		from	to	from	to		
Chevrolet	Malibu	2016	2022	—	—	1.5L Turbo (LFV)	—

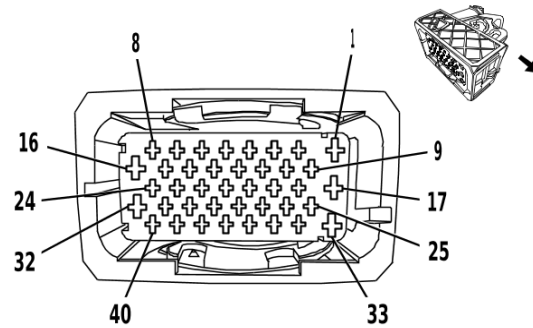
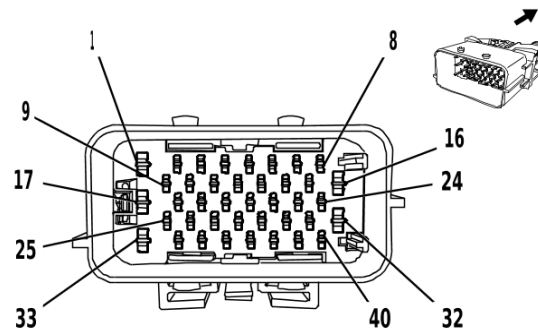
Involved Region or Country	North America, Israel, Palestine
Condition	<p>Some customers may comment on one or more of the following conditions:</p> <ul style="list-style-type: none">• Loss of power• MIL illuminated• Gauges dropping out• Multiple warning lights and/or messages <p>Technicians may find one or more of the following DTCs stored in the Engine Control Module (ECM):</p> <ul style="list-style-type: none">– P0700, P150C, P15FD, P2544, P308D, U0073, U0101, U0129, U0140, U0146, U183A, U18D5, U18D7, U2413, U0121, U0100, U0401, U0131
Cause	This condition may be caused by high resistance on the HSCAN BUS circuits 2500/2501 between the Electronic Brake Control Module (EBCM) and the Power Steering Control Module (PSCM).

With the battery disconnected, verify the resistance of the HSBUS circuits across 2500, 2501 splitting the circuit at the X115 electrical connector. Refer to Master Electrical Component List in SI. Looking for any unwanted resistance (ex. 126.7 or something other than in the range of 120 ohms). If stray resistance is traced down to one of the module connector terminals, verify terminal tension and ensure there is no damage to the terminal. If the terminal is good, then apply dielectric grease to the terminals.

If the terminals are damaged or have poor terminal tension, replace with terminated leads at the suspect module connector and apply dielectric grease to the connector.
