Service Bulletin

Bulletin No.: 22-NA-072

Subject: Fuel Rail or Intermediate Fuel Feed Pipe Retrofit Procedure

Brand:	Model:	Model Year:		VIN:		Engine:	Transmission:
		from	to	from	to		
Cadillac	CT6	2019	2020	—	—	4.2L Twin-Turbo (RPO LTA)	—

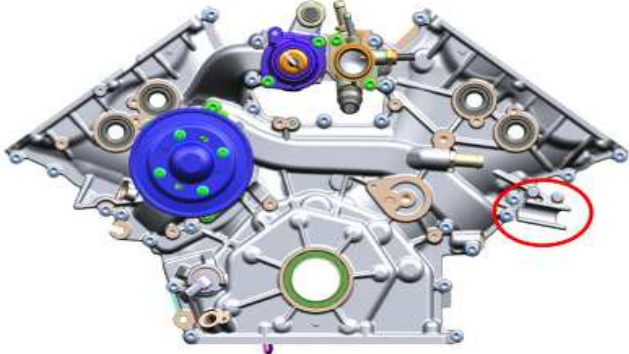
6003768

Involved Region or Country	North America
Condition	Some technicians may determine that the fuel feed pipe or fuel rail needs to be removed and replaced in order to perform a specific repair, then a new fuel feed pipe along with the fuel rail and several other components will need to be installed to complete the repair.
Cause	This condition may be caused by a dimensional change to the fuel feed pipe and fuel rail assembly during the 2019 model year. This change prompted a release of a 2nd design fuel feed pipe, fuel rail assembly, oil cooler pipe and engine front cover. This second design fuel feed pipe or fuel rail assembly will not back service an engine that was originally equipped with the 1st design fuel feed pipe, fuel rail assembly or engine front cover.
Correction	<p>To retrofit the engine to accommodate these 2nd design parts differences, it will be necessary to replace the fuel rail assembly, fuel feed pipe and engine oil cooler pipe to completely update the engine to the latest service content. There were also 2 designs of the engine front cover that were released in production. One with the fuel pipe channel (shown below) and one without. Before ordering the parts, you will need to determine which front cover you have. If you have the 1st design front cover (shown below), you will need to order a new engine front cover to complete the repair. If the front cover does not have the channel, you do not need to replace the engine front cover.</p> <div style="text-align: center;">

Refer to *Engine Front Cover Replacement* in the Service Manual.
