Service Bulletin

Bulletin No.: 22-NA-177

Subject: Information On Intermittent or Inoperable Rearview Camera, May Display Blue or Black Screen With Error Message

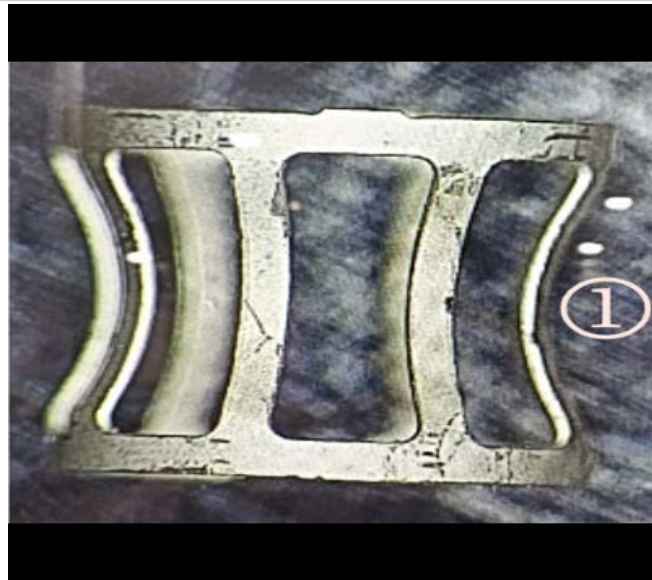
6100425

Involved Region or Country	United States, Canada, Mexico, Middle East, Israel, Palestine, Brazil (Mercosur), GM Korea Company, Australia/New Zealand
Additional Options (RPOs)	Equipped with RPOs UVB or UV2
Condition	Some customers may comment on their rearview camera acting intermittently or inoperable and may display a blue or black screen with an error message.
Cause	The cause of the condition may be a missing barrel spring in the harness connector.

Remove the rear closure fixed handle applique and disconnect the connector to inspect the harness connector contact area and verify if the barrel spring (1) is present in the cable inside the connector. Refer to *Rearview Driver Information Camera Replacement* in SI.
