Thor Motor Coach Technical Service Bulletin

TSB #	TSB 22-10		
Description/Title:	Tuscany with optional motorized slide tray		
Affected Product Line(s):	Certain model year 2022 Tuscany		
Service Campaign # :	RC000274	Released Date:	
Codes:	Repair: TMCTS80277W	Document Date:	9/19/2022
Time Allowed:	Repair: 0.2	Document Revision:

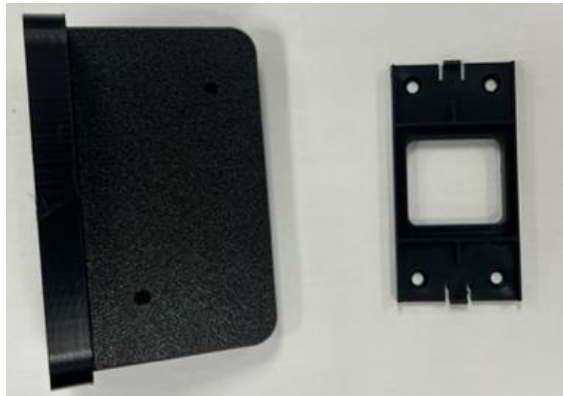
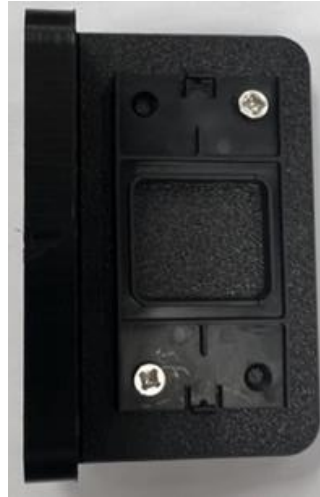
Optional motorized slide tray movement signal delayed or no signal present at all.

1. Open baggage door and remove the switch cover and screws holding the switch bracket to the door.
2. Take the switch bracket and attach it to the side of the new bracket as shown below using the pre-drilled holes in the side of the new bracket.
