THIS IS A TECH TIP, NOT A TECHNICAL BULLETIN.

Applicable Vehicles					
Model(s)	Year	Eng. Code	Trans. Code	VIN Range From	VIN Range To
Atlas, Atlas Cross Sport	2021, 2022	All	All	All	All

A pop noise may be heard from the roof rail area when moving the vehicle.

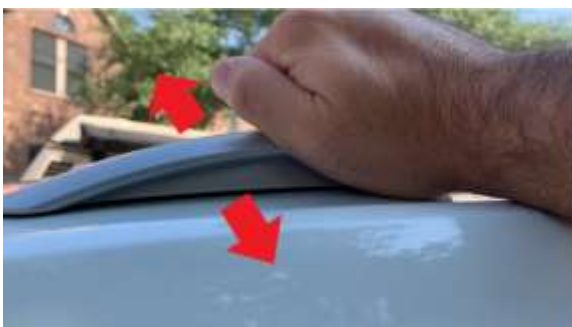
Figure 1

The nuts that secure the roof rails may not have sufficient torque and a popping noise may be heard. This concern can sometimes be duplicated by grasping the roof rail in question and rocking the rail back and forth. This noise may sound like an acorn bouncing off the roof panel.

Rock the roof rail back and forth in an attempt to duplicate the noise.

Lower the headliner, torque the roof rail mounting nuts per the repair manual instruction in ELSA Pro, and note if additional rotation is present. If additional rotation is present, replace the mounting nuts, apply thread locking compound, and torque them per the spec in ELSA Pro. Please refer to the photos below for examples of the additional rotation and how to inspect for the noise.

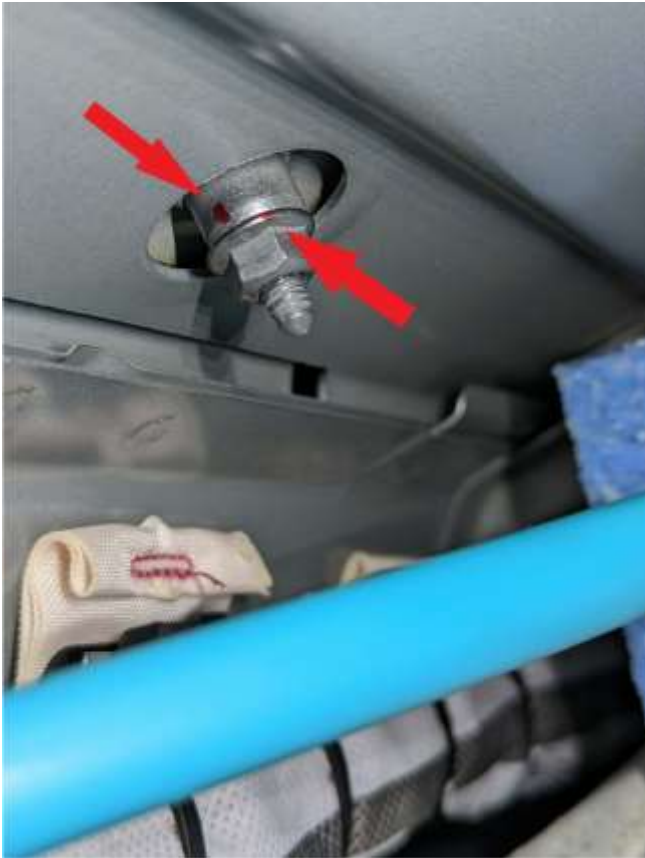
Figure 2

Example of additional rotation at the mounting nut.
