IMPORTANT SAFETY RECALL

COMPONENT/SUPPLIER RECALL CSR-3023-A

Steering Assembly U-Joint Pinch Bolts (Freightliner FL937A — NHTSA 22V394)

Subject: Freightliner Steering Assembly U-Joint Pinch Bolts

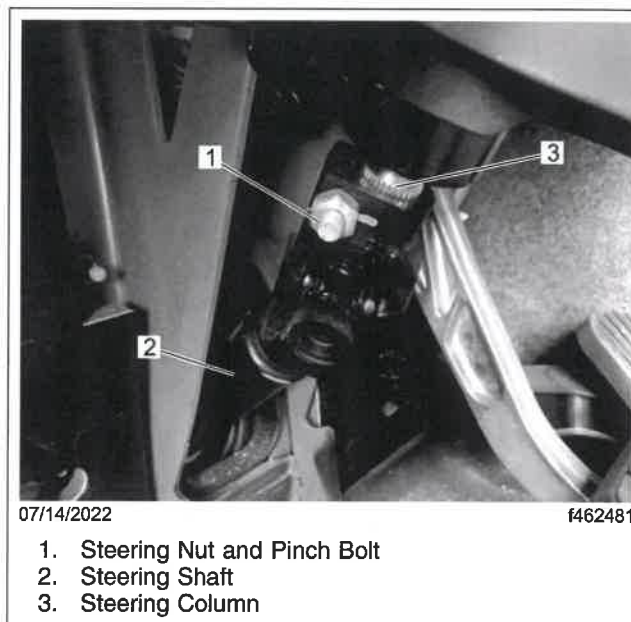
Fig. 1, Steering Pinch Bolt Location

1. Park the vehicle on a level surface, shut down the engine, and set the parking brake. Chock the rear tires.
2. Locate the steering shaft inside the cab, as shown in [Fig. 1](#).
3. Check the connections between the steering column and steering shaft, and the nut to pinch bolt connection, as shown in [Fig. 1](#). Remove the steering column cover to see the bolt.
4. Inspect the nut to pinch bolt connection. There must be bolt threads exposed beyond the nut as shown in [Fig. 1](#).

Are the bolt threads visible?

NO → **DO NOT** drive the vehicle. Have it immediately towed to the nearest DTNA dealership for repair.

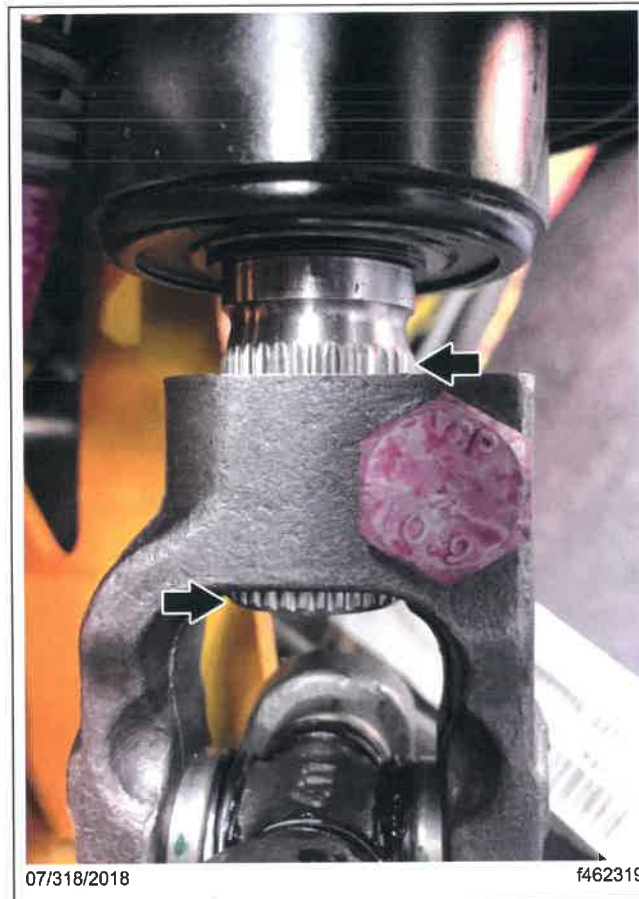
Fig. 2, Steering Shaft Splines

5. Inspect the exposed splines of the steering shaft connection as shown in **Fig. 2**. It may be necessary to turn the steering wheel to gain adequate visibility of the splines.

If the steering shaft splines are not visible on both sides of the bolted connection, **DO NOT** drive the vehicle. Have it immediately towed to the nearest DTNA dealership for repair.

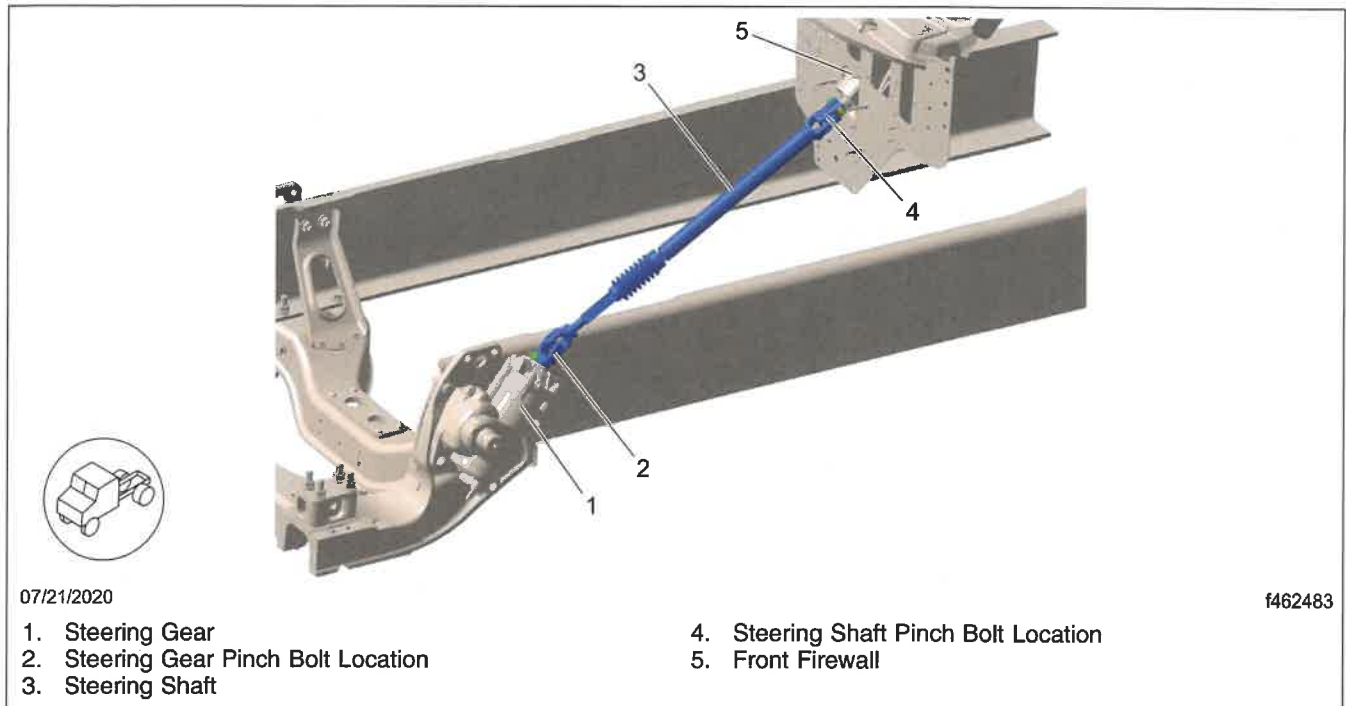
Fig. 3, Steering Assembly

1. Open the hood.
2. Locate the universal joint of the steering shaft at the front of the firewall. See [Fig. 3](#) and [Fig. 4](#).
3. Check the connections between the steering column and the steering shaft at the front of the firewall, and the nut to pinch bolt connection. See [Fig. 4](#).

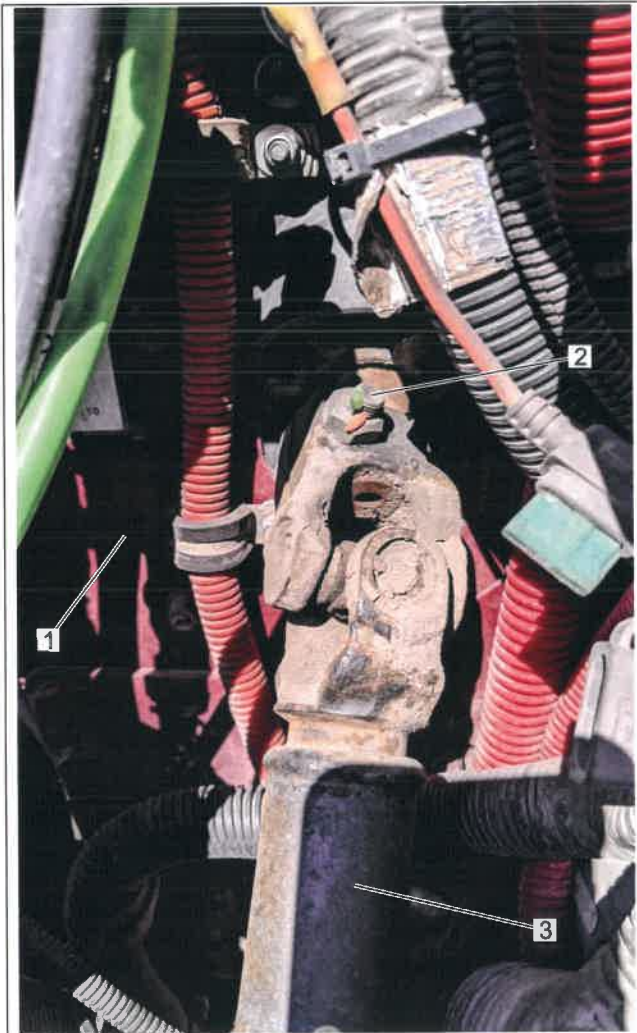
Fig. 4, Pinch Bolt and Front Firewall Location

4. Inspect the nut to pinch bolt connection. There must be bolt threads exposed beyond the nut as shown in [Fig. 1](#).
Are the bolt threads visible?
YES → Go to the next step.
NO → **DO NOT** drive the vehicle. Have it immediately towed to the nearest DTNA dealership for repair.
5. Inspect the exposed splines of the steering shaft connection as shown in [Fig. 2](#). It may be necessary to turn the steering wheel to gain adequate visibility of the splines.
If the steering shaft splines are not visible on both sides of the bolted connection, **DO NOT** drive the vehicle. Have it immediately towed to the nearest DTNA dealership for repair.
If the steering shaft splines are exposed on both sides of the bolted connection, go to the next inspection.

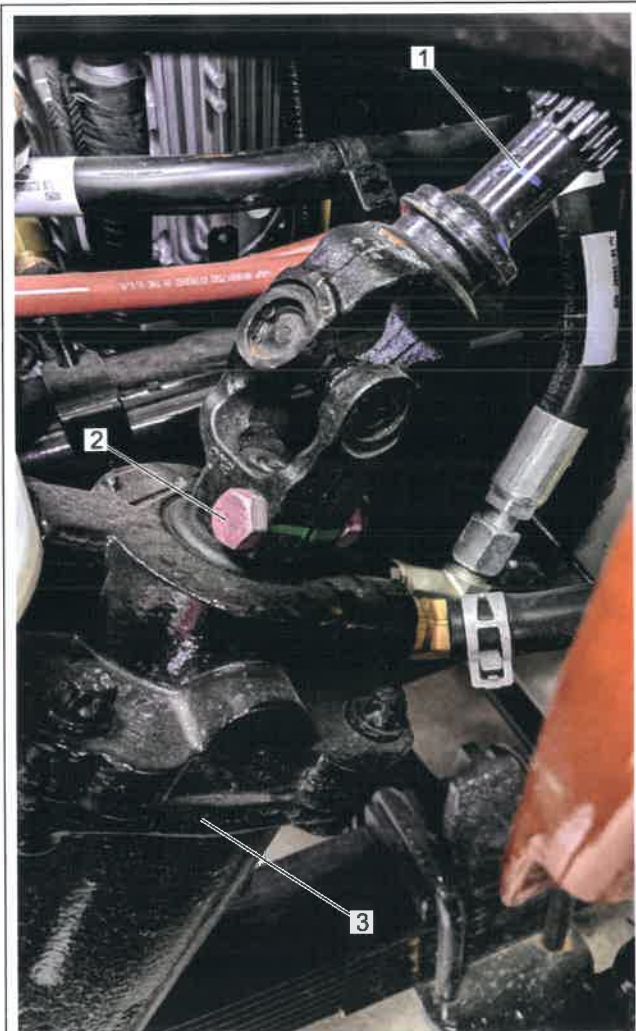
Fig. 5, Pinch Bolt and Steering Gear Location

1. Locate the universal joint at the steering gear. See **Fig. 3** and **Fig. 5**.
2. Check the connections between the steering shaft and the steering gear, and the nut to pinch bolt connection. See **Fig. 5**.

3. Inspect the nut to pinch bolt connection. There must be bolt threads exposed beyond the nut as shown in **Fig. 1**.

4. Inspect the exposed splines of the steering shaft connection as shown in **Fig. 2**. It may be necessary to turn the steering wheel to gain adequate visibility of the splines.

If the steering shaft splines are not visible on both sides of the bolted connection, **DO NOT** drive the vehicle. Have it immediately towed to the nearest DTNA dealership for repair.
