Technical Service Bulletin

37 Vehicle Does Not Accelerate After Coming To A Stop. SAFE Warning Displayed On Instrument Cluster

37 22 07 2067546/2 September 19, 2022. Supersedes Technical Service Bulletin Group 37 number 22-06 dated July 14, 2022, for reasons listed below.

Model(s)	Year	VIN Range	Vehicle-Specific Equipment
e-tron GT, and RS e-tron GT	2022 – 2023	All	Not Applicable

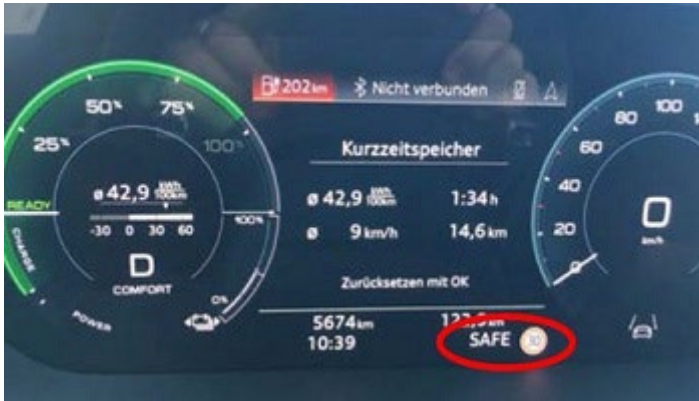
Upon the vehicle resting at a stop, for a period of time greater than 30 seconds, the vehicle will no longer accelerate.

“SAFE” warning is shown by the instrument cluster (Figure 1).

Figure 1: "SAFE" warning is shown by the instrument cluster

If a button on the remote key is pressed and held for longer than 60 seconds while driving, it is possible that a reset of the convenience control module J393 (address word 0046) may occur.

If the convenience control module J393 (0046) performs a reset, the vehicle is prevented from accelerating at the next stand still event lasting over 30 seconds.

Update convenience control unit J393 (DA0046) with SVM. To enter the SVM code, use "Flash" mode on the ODIS tester. The SVM code is **46A032**. Follow the instructions on the tester.

1. Follow all instructions in TSB 2011732: *00 Software Version Management (SVM), operating instructions*.
2. Update the control module J393 (0046) using the SVM action code as listed in the table below, if necessary:
