# Customer Satisfaction Program

## N212354520 Heated Vented Seats Retrofit Due to Chip Shortage - Front Seats Only

**Release Date:** September 2022

**Revision:** 01

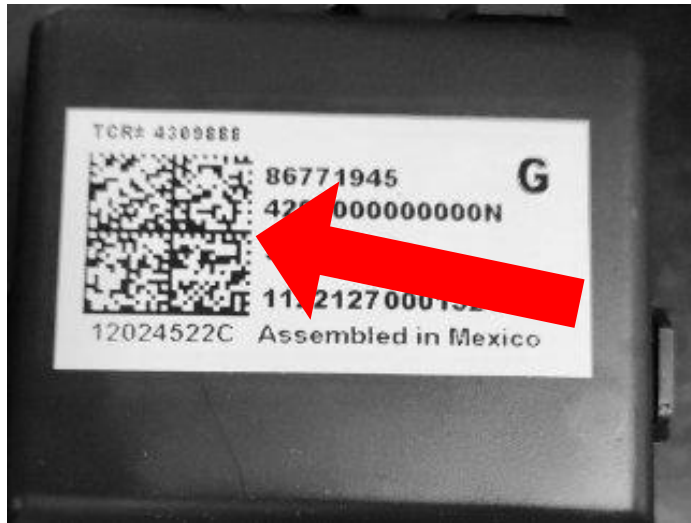
6098077

1. Scan the VIN (door pillar QR code or windshield VIN barcode) and
2. Scan the new part (QR code) and
3. Check the information and if correct then, Submit.

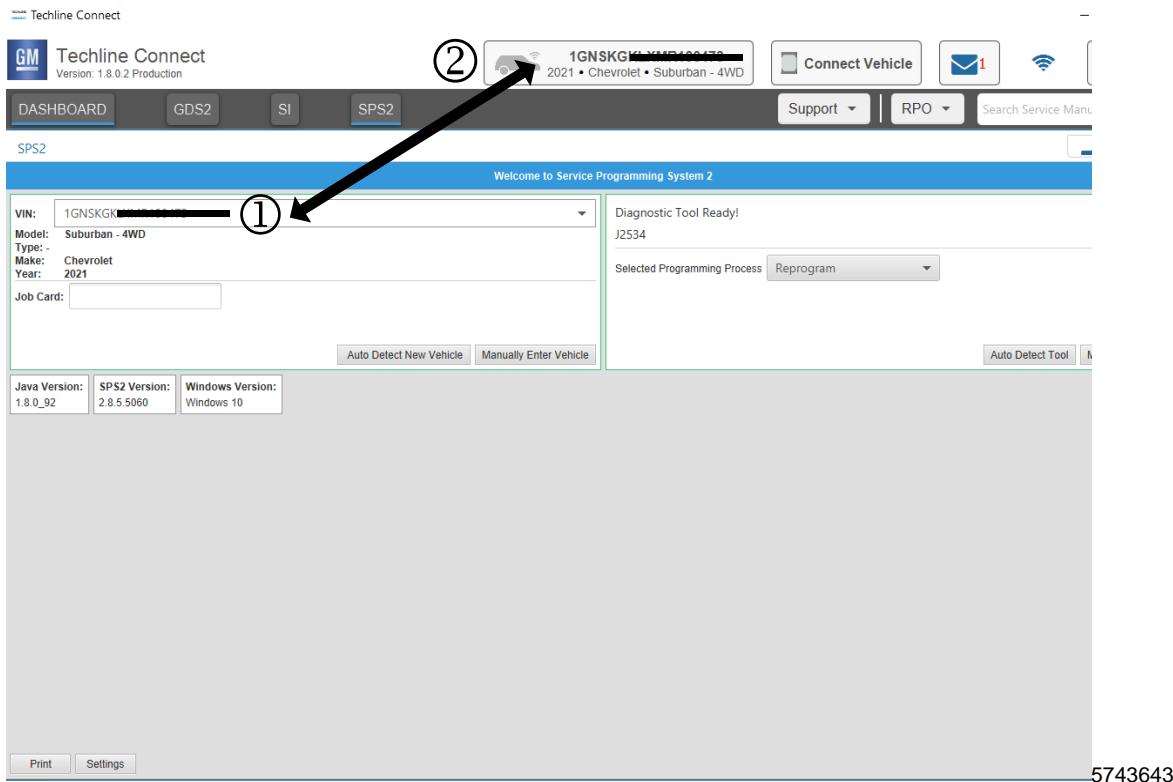
**Caution:** Be sure the VIN selected in the drop-down menu (1) is the same as the vehicle connected (2) before beginning programming.
