Technical Service Bulletin

87 Air Conditioning is inoperative, DTC B11AE15

87 22 32 2067362/2 September 20, 2022. Supersedes Technical Service Bulletin Group 97 number 22-84 dated June 22, 2022,
for reasons listed below.

Model(s)	Year	VIN Range	Vehicle-Specific Equipment
Q8	2020 – 2023	All	Not Applicable
SQ8, and RS Q8	2021 - 2023

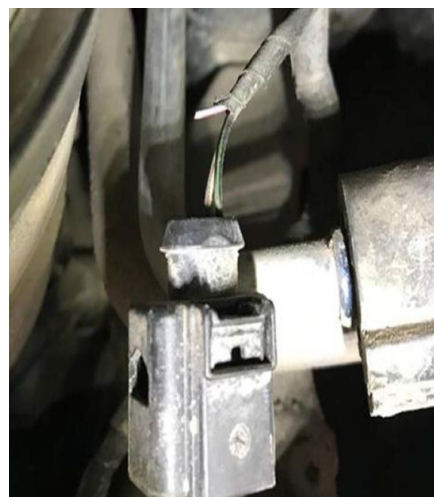
The wiring to the A/C compressor connector T3r is not long enough. Wires may become stretched, broken, or pulled from the connector as a result.

If DTC B11AE15: A/C compressor regulator valve Open circuit/short circuit to B+ is stored in the onboard supply control unit J519 diagnostic address 0009, inspect the wiring at connector T3r in the area of the A/C compressor as seen in Figure 1.

Figure 1. N280 control wire damaged at T3r connection

If damage is found in this area, all 3 wires will need to be extended following the directions below.

1. Cut back the damaged wire(s) until the wires are clean and free of any corrosion.
2. Extend all 3 wires so that a length of approximately 110mm is achieved when measuring from the base of the connector to the first branch in the harness. See Figure 2.
3. Ensure there is enough slack to keep the harness from stretching however not so much the wires hang down.
4. Repair and modify the harness using VAS 1978 B.
5. Wrap the harness section using fabric adhesive tape **N 105 920 02**.
Wrap wires up to 20mm from the base of the connector housing, as seen on the original harness in Figure 1.
6. Clear faults and perform a functional check.

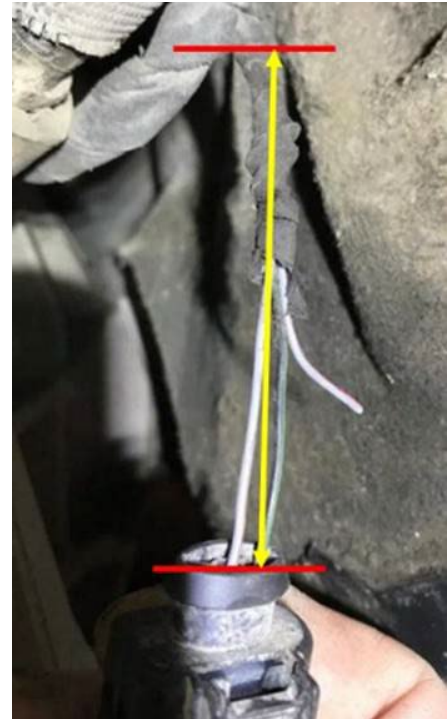
Figure 2. Measure 110 mm from T3r to the first harness branch
