Technical Service Bulletin

91 No diagnostics communication to the telematics control module

91 22 25 2056076/15 September 14, 2022. Supersedes Technical Service Bulletin Group 91 number 22-20 dated August 11, 2022, for reasons listed below.

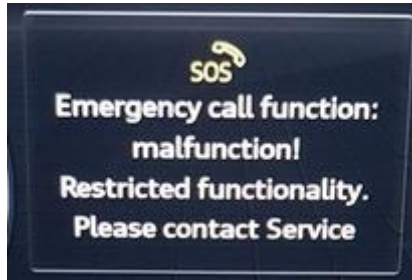
- An SOS Warning might be displayed in the instrument cluster (Figure 1).

Figure 1. Emergency call malfunction warning.

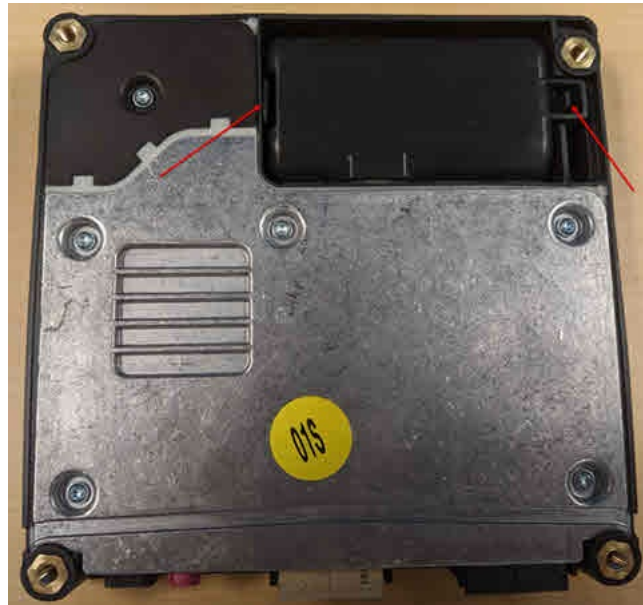
Figure 2. Backup battery compartment location.

1. Remove and unplug the telematics control module, J949 (address word 0075) according to the Elsa Repair Manual.
2. Open the battery compartment of the telematics control module, J949 (address word 0075), and disconnect the backup battery (Figures 2 - 3).

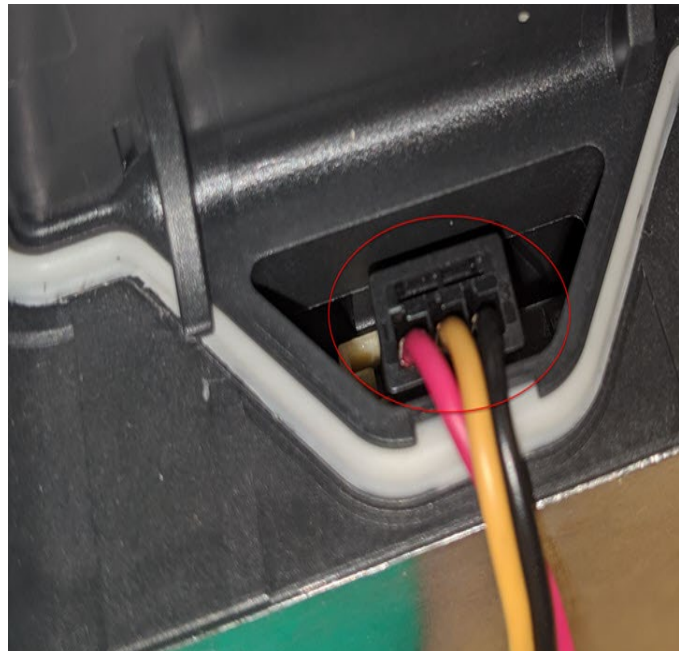
Figure 3. Backup battery connector (no release mechanism).

- Leave the battery and Gateway fuse disconnected for approximately 20 minutes.
- Reinstall the backup battery back into the telematics control module, J949 (address word 0075).
- Reinstall the telematics control module, J949 (address word 0075) back into the vehicle.
- If ODIS **still cannot** connect to the telematics control module, J949 (address word 0075) **or it is a repeat repair**, then follow the ODIS test plan and replace the telematics control module with part number 992 035 286 C.
