Technical Service Bulletin

91 SOS Emergency call function deactivated message in the cluster, DTC U153E00 is stored in the telematics module

91 22 26 2055945/11 September 14, 2022. Supersedes Technical Service Bulletin Group 91 number 22-21 dated August 11, 2022, for reasons listed below.

Model(s)	Year	VIN Range	Vehicle-Specific Equipment
A4 allroad, A4, S4, A5, A5 Cabriolet, A5 Sportback, S5, S5 Cabriolet, S5 Sportback, A6, A7, A8, and Q8	2019 – 2020	All	ConBox High

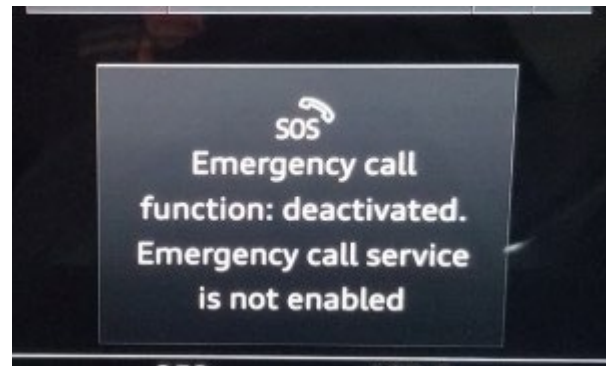
- The warning message "SOS Emergency call function deactivated" is seen in the instrument cluster (Figure 1 or 2).

Figure 1. SOS warning in the instrument cluster.

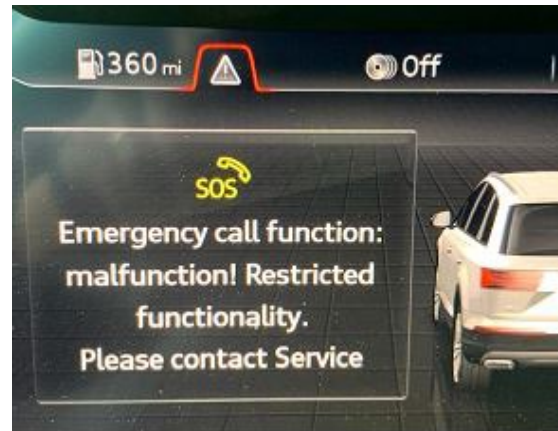
Figure 2. SOS warning in the instrument cluster.
