STAR ONLINE PUBLICATION

Case Number: S2223000020

Symptom/Vehicle Issue: Rattle Noise From Roof Area Near Rear Of Sunroof

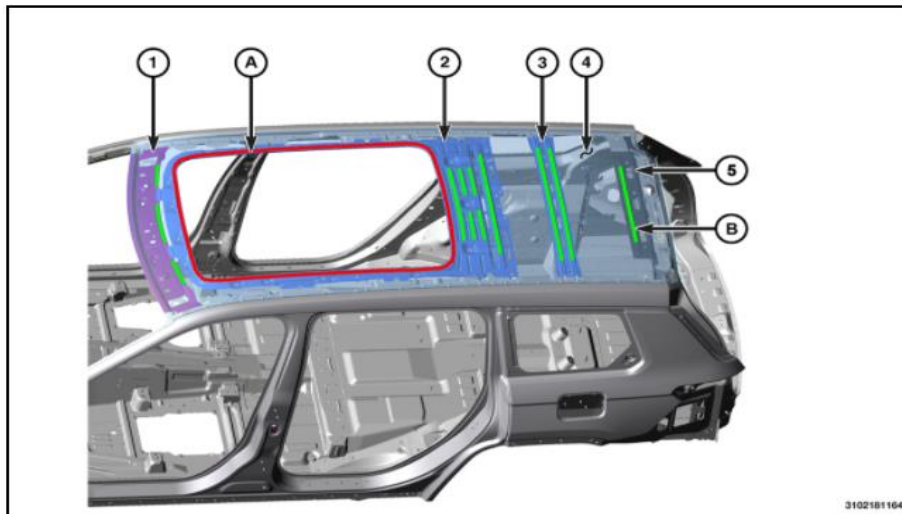
Discussion: Inspect at the rear of the sunroof (under the headliner) to ensure that the center roof bow is adhered/bonded to the roof. Use a fiber trim stick inserted between the skin and bow to check for movement. If movement exists, see the below information.

Green- Location of Anti Flutter Foam used to adhere roof skin to cross bows.

List of approved Anti Flutter adhesives

Lowering of the headliner will be required to inspect the roof area. Refer to 23 - Body / Interior / HEADLINER / Removal and Installation; Group 31- Collision Information; Adhesive manufacturer's instructions for handling, application, and cure times.

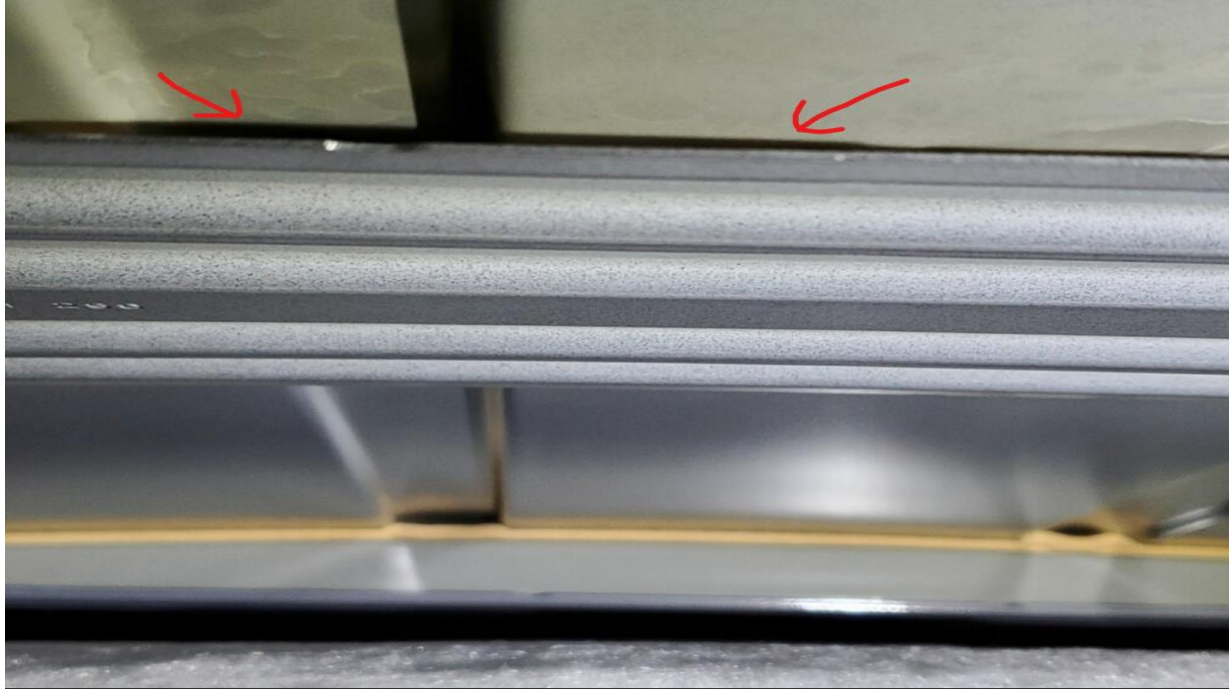
Example of missing anti flutter adhesive.
