STAR ONLINE PUBLICATION

Case Number: S2208000082

Symptom/Vehicle Issue: Service 4WD Message Is Displayed In The Instrument Cluster

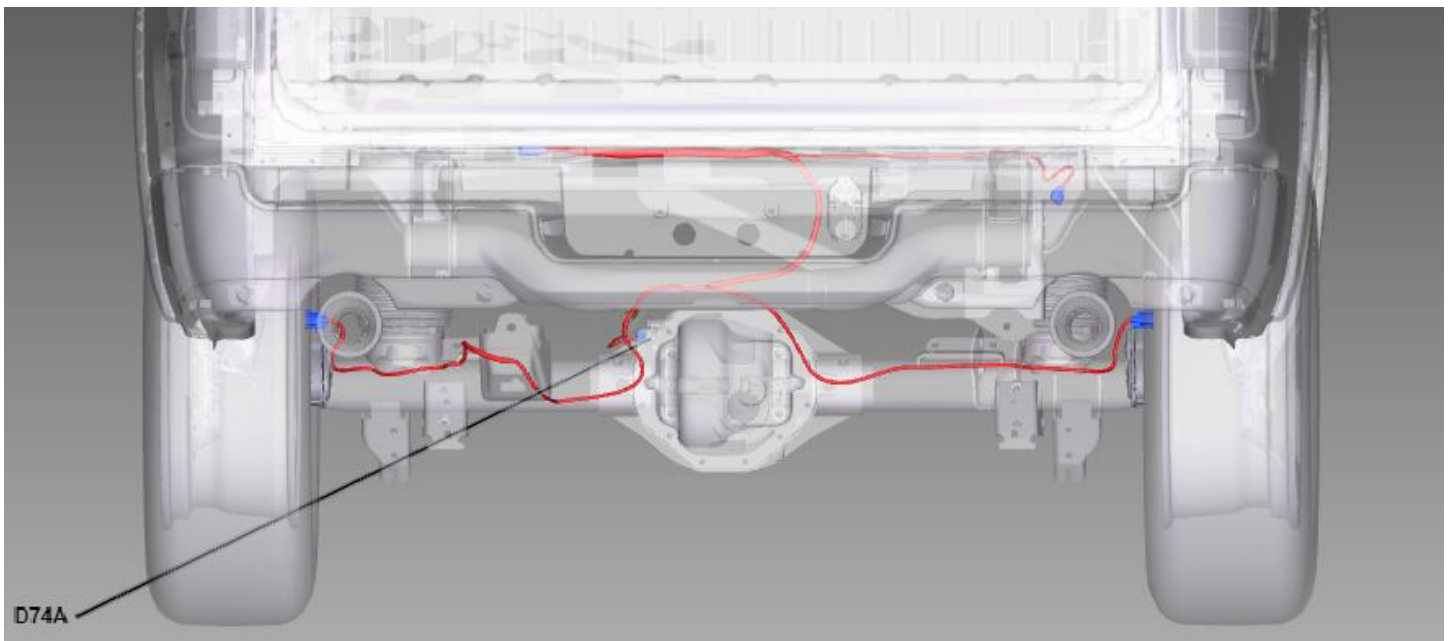
Discussion: The message to service 4WD is displayed in the cluster. Upon scanning the vehicle for DTC's you will find a C141C. This may be caused by Terminal Push Out (TPO) of the T528 (Rear Locker Control Return)YE/GY circuit at the D74A connector.

Diagnosis: Disconnect and inspect the D74A connector on the rear differential axle locker. Inspect for terminal push out.

Repair Procedure: If a pushed out terminal is found. Verify the terminal locking tab is intact. If an issue is found with the connector housing, replace the connector. Otherwise, re insert the terminal and confirm it is fully locked and engaged.
