## STAR ONLINE PUBLICATION

**Case Number:** S1908000159 REV. A

**Symptom/Vehicle Issue:** MIL Lamp On, DTC P0330 Knock Sensor 2 Circuit

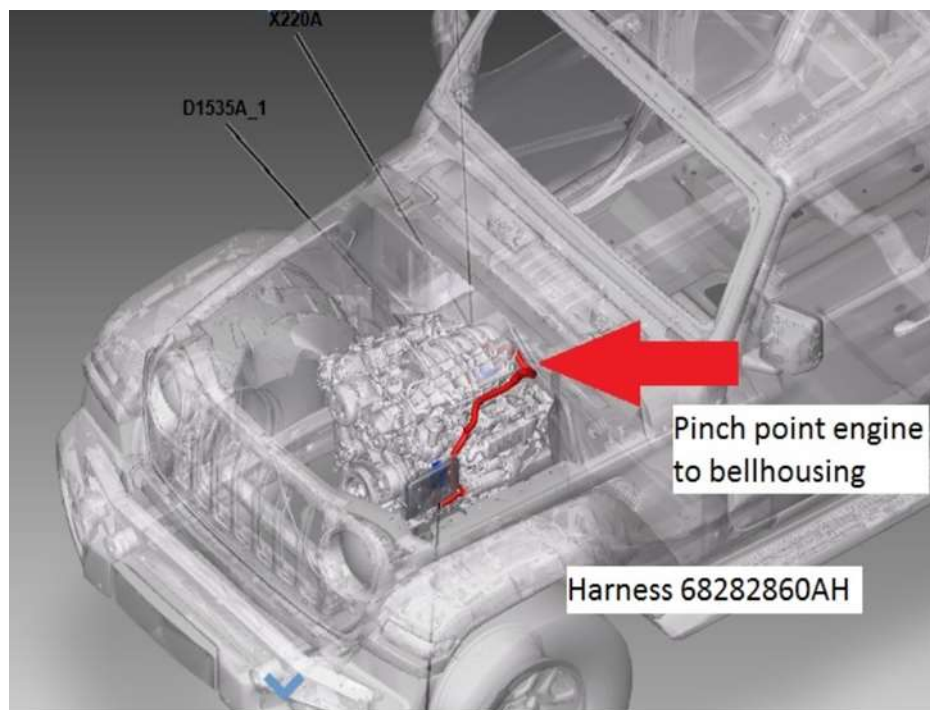
Fig 1

**Customer Complaint /Technician Observation:** Owner complains of an Intermittent MIL lamp on. Technician observed DTC P0330 Knock Sensor 2 Circuit, stored or active.

**Discussion:** Inspect the harness routing at the rear motor at the rear of the head / transmission bell housing location for any areas of pinching or contact. Inspect the harness routing for any contact areas between the transmission bellhousing and engine block. Repair any suspect harness damage and isolate the harness as needed from contact areas. No parts required Fig 1, 2.

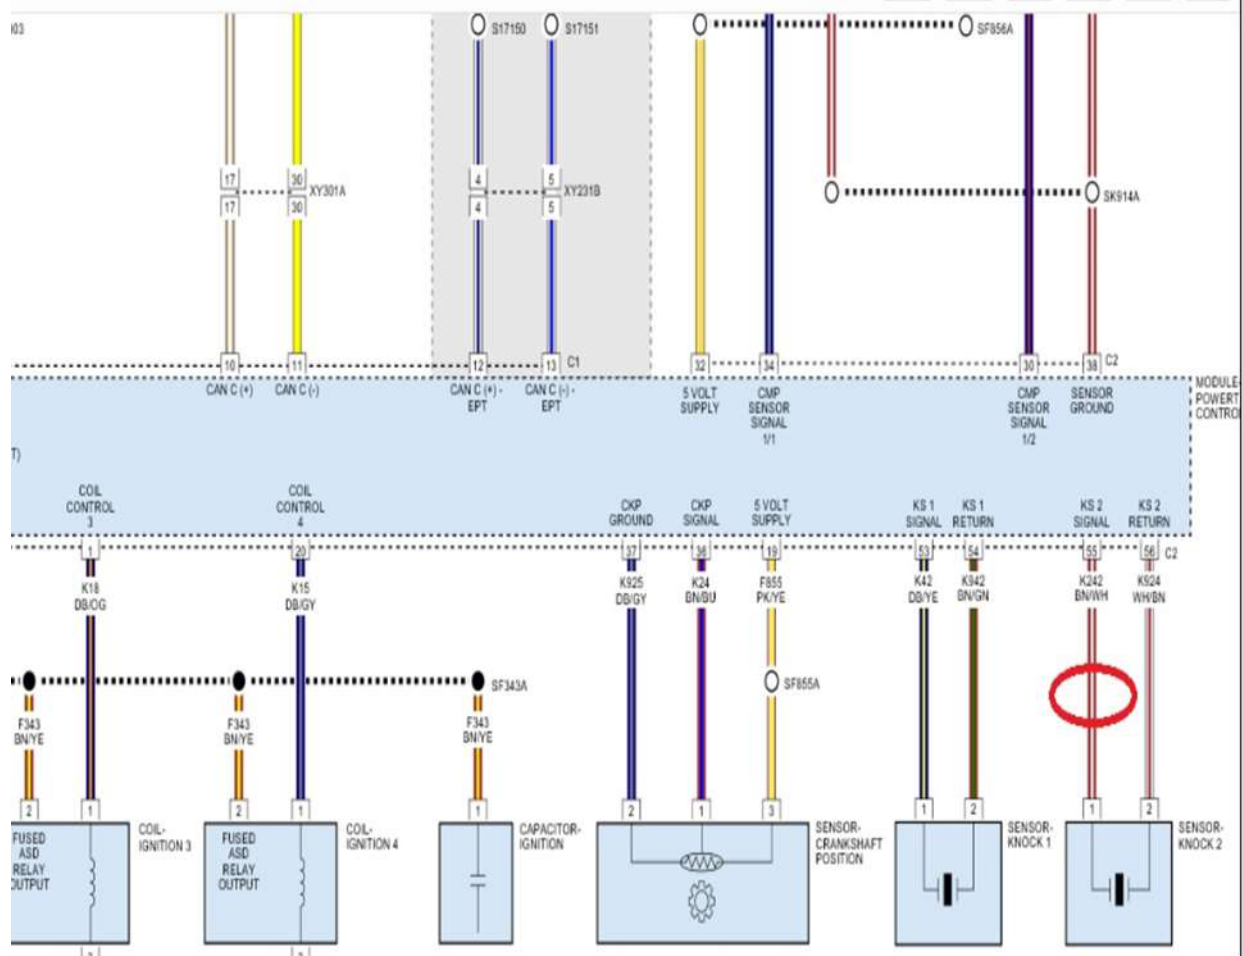
### Wiring Diagram - IGNITION SYSTEM - 2.0L

Fig 2 affected circuit in this case.
