**NUMBER:** 23-010-22

Rear Windshield Wash Low Fluid Output / Inoperable

2022 (WS) Grand Wagoneer/Wagoneer

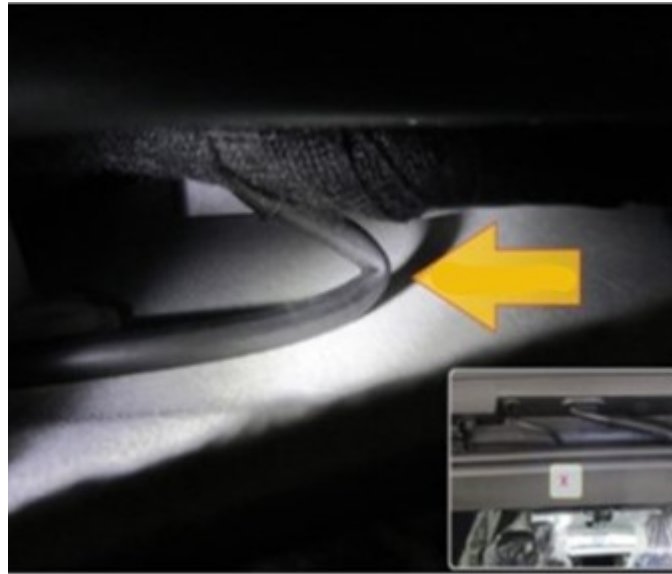
- The rear wiper wash is inoperative, or low fluid output.

**Fig. 1**  
**Rear Washer Hose Kink**

1. Cycle the rear washer spray. Does it have weak fluid output?
  - YES>>> Proceed to [Step 1](#)
  - NO>>> This bulletin has been completed, use inspect LOP (23-43-10-96) to close the active RSU.
1. Remove the D-Pillars. Refer to the detailed procedures available in DealerCONNECT > Service Library> under: 23 - Panel, D-Pillar Trim Removal and Installation.
2. Lower the headliner at the rear.
3. Adjust the washer hose to remove any kinks ([Fig. 1](#)) .

4. Reposition the headliner at the rear.
5. Install the D-Pillars. Refer to the detailed procedures available in DealerCONNECT > Service Library> under: 23 - Panel, D-Pillar Trim Removal and Installation.
