NUMBER: 23-013-22

Front Fascia Misaligned with the Fender

2019 - 2021 (WD) Dodge Durango

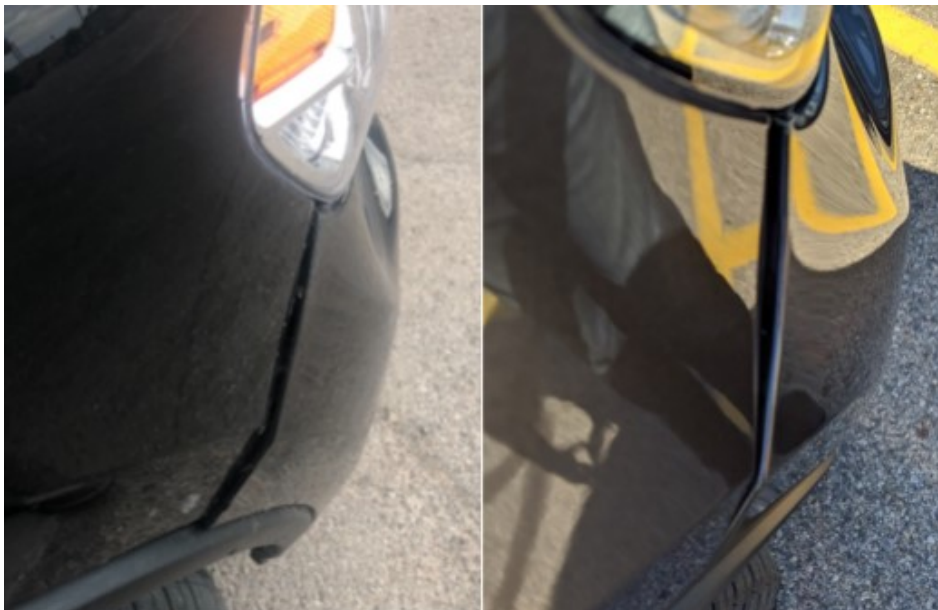
The customer may describe that the front fender is not properly aligned with the front fascia (Fig. 1) .

Fig. 1
Fender to Fascia Mis-Aligned

This bulletin involves replacing both the front fender brackets if needed.
