NUMBER: 08-031-22 REV. A

GROUP: 08 - Electrical

Radio Over The Air Software Version Updates

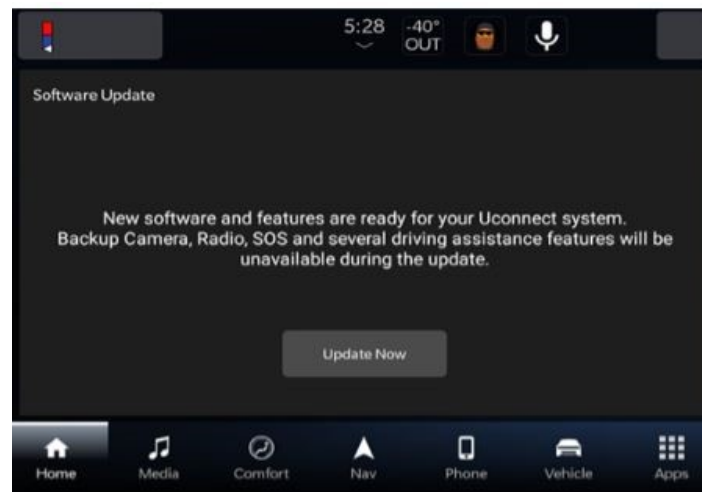
Fig. 1

Software Acceptance Screen

1. The vehicle needs to be in 'park'. The ignition needs to be in the off position.
2. If the customer selects "Update Now" they can shut off the vehicle and leave. The update will be completed automatically.

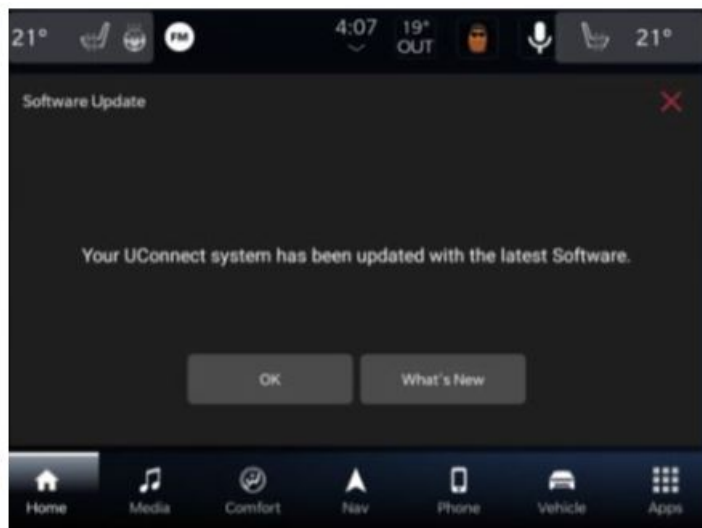
3. Upon completion of update, the radio will display a confirmation message (Fig. 2) .

Fig. 2
Software Update Confirmation Screen
