Case Number: S2108000270 Rev A

Symptom/Vehicle Issue: Sky Slider Power Top Does Not Operate. New Power Top Motors Inoperative

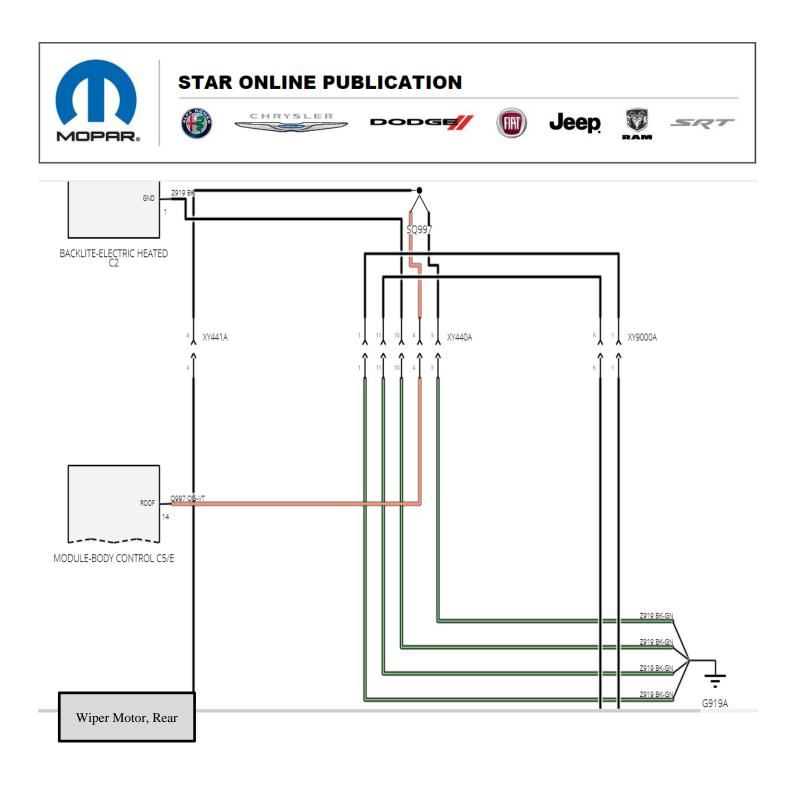
Pg2

Repair Procedure: The cluster provides warning messages when ignition is first turned "on" and or during a power top open/close request. If there are no EVIC messages (see list below), check to see if the rear wiper motor will turn on. If the rear wiper does not function, check the BCM roof sense ground circuit, Pg 1-2.

Pg 1 Check pin 14, Q997 circuit, C5 connector at the BCM for proper grounding.
