## STAR ONLINE PUBLICATION

**Case Number:** S2208000124

**Symptom/Vehicle Issue:** U0184 Loss Communication With Radio Setting In Multiple Modules

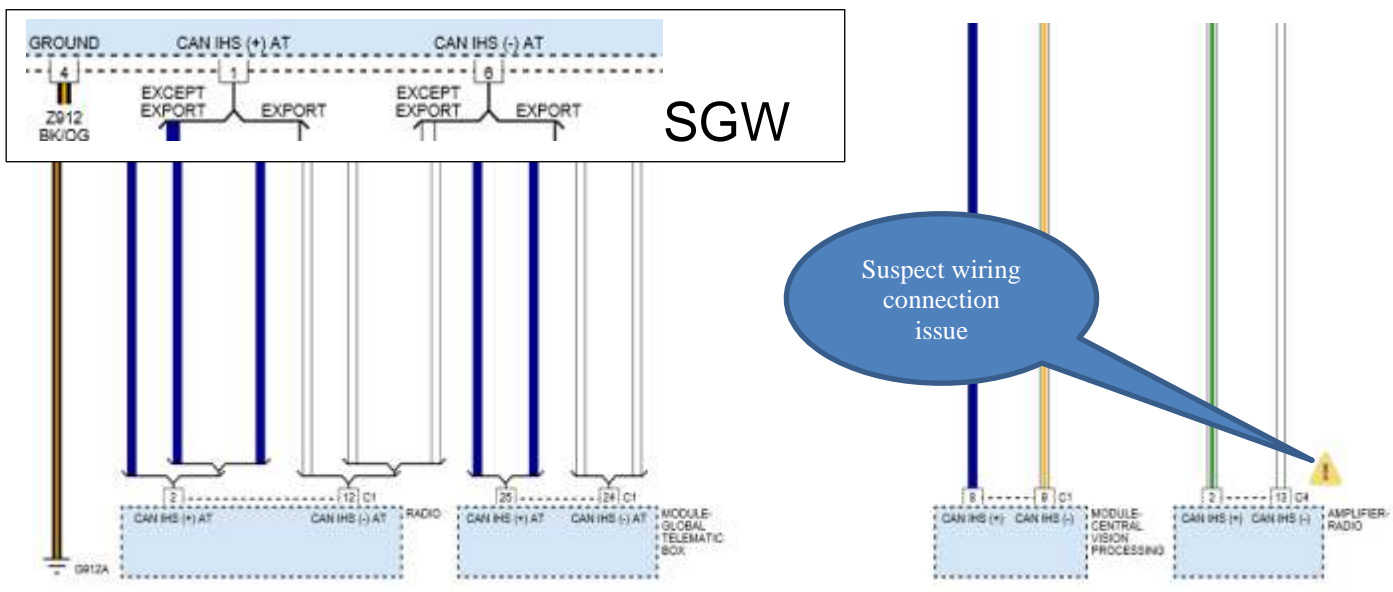
Perform a harness wiggle test for an intermittent concern while monitoring the (AT or IHS) BUS voltage. See Service Library for any highlighted wiring locations as a suspect area to inspect prior to module replacement, example below JL- Wrangler connection highlighted.

**Repair Procedure:** If DTC U0184 - Lost Communication With Radio has been set and it is a STORED DTC, clear the DTC, inspect (AT or IHS) BUS circuits at Security Gateway (SGW) and radio for a spread or pushed out terminals. This DTC is rarely caused by a SGW internal module fault. If active, continue with the service diagnostic procedure outlined in Service Library.
