STAR ONLINE PUBLICATION

Case Number: S1808000265 REV. A

Symptom/Vehicle Issue: Key Programming Process, Key Already Programmed Message, Low Battery Message

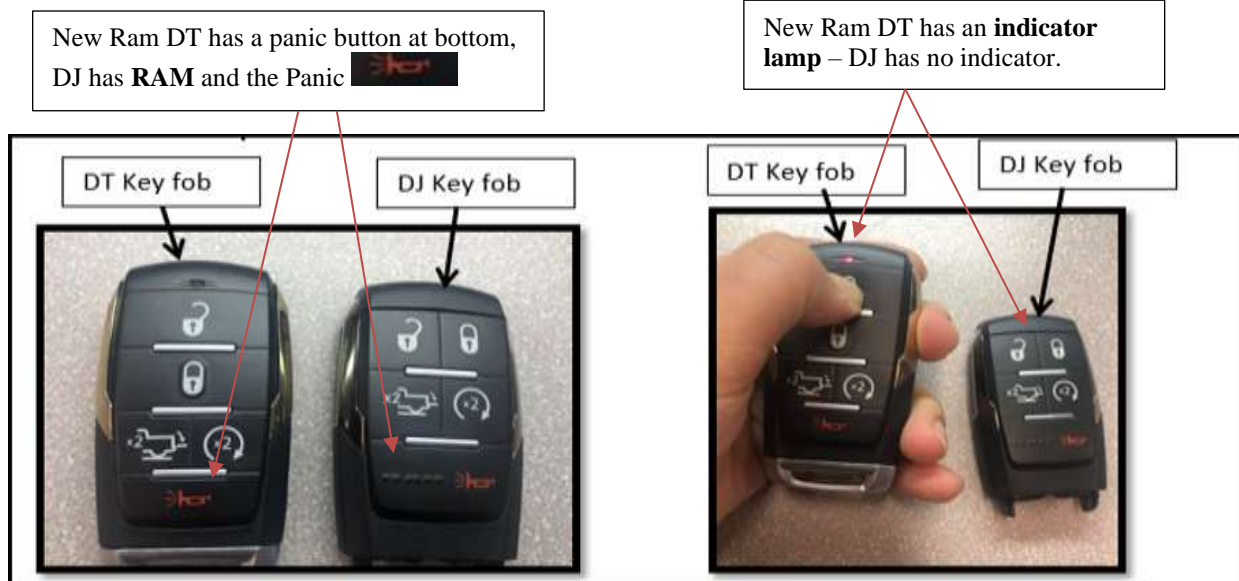
Example: validate the correct Fobik for New Ram 1500 key programming:

1. A method to verify if the Fobik belongs to the vehicle is by pressing the fob against the KIN or by pressing the KIN with your finger with only one Fobik inside the vehicle. The cluster should illuminate with the KIN button press and the KIN should move from the off position.

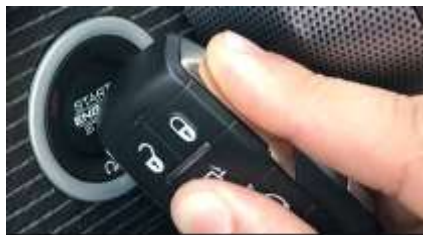
failure reason: **Transponder** - Failure: “FOBIK is Not Blank” or “Key Already Programmed” message

1. Check the position of the fob during the programming.
 - a. Make sure you use the left front corner of the fob when buttons facing up and turned slightly to the driver’s door (see picture moving or turning the Fobik as pictured can improve the pairing process, but it must be held in position until a successful programming message is provided by the scan tool).
