STAR ONLINE PUBLICATION

Case Number: S2108000060 REV. B

Symptom/Vehicle Issue: Service Park Assist Message Or Rear Park Assist Unavailable Message Displaying On The Cluster

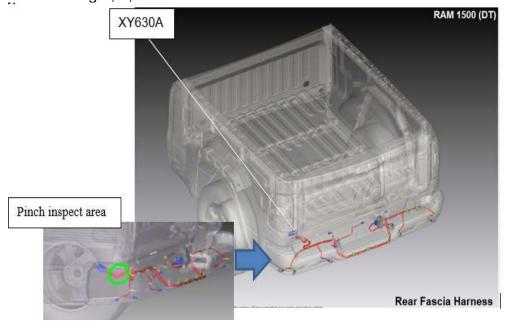
Fig 1

Customer Complaint/Technician Observation: Owner complains of repeated warning messages on the cluster display for the park assist to "Service Park Assist". Technician observed the message and located one or multiple DTC's B1294-11, B1295-11, B1296-11, B1297-11, B1298-11 SENSOR CIRCUIT(s) Short OR OPEN, B16E7-15 B16E7-15-LICENSE PLATE LAMP CONTROL-CIRCUIT SHORT TO BATTERY OR OPEN.

Repair Procedure: Inspect inline gray 24-way connector XY630A, located behind the rear left wheel liner; clipped into a small frame bracket. Perform a slight pull test to validate any loose terminals and or Terminal Push Outs (TPO). Inspect all terminals at the connector for any signs of corrosion, clean and secure to complete; service kit 68353351AA for XY630A can be used if required for the involved circuits Fig 1, 2, 3.
