## STAR ONLINE PUBLICATION

Case Number: S2208000050 REV. B

Symptom/Vehicle Issue: Vehicle Will Not Start

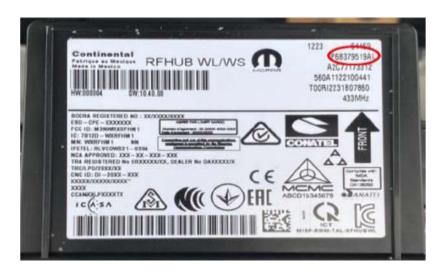
Check to see if the Radio Frequency Hub (RFHM) label part number is at "AM" NIK level.

- A. Using a trim stick or equivalent, disengage the retaining tabs of the rear header trim panel from the inner roof panel and remove the trim panel.
- B. Lower the headliner to access the Radio Frequency Hub Module **RFHM** located at the center rear.
- C. Inspect the label part number on the RFHM, does the RFHM part number end with an "AM"?

- **1.** If the RFHM is at the "AM" NIK level, the RFHM will need to be replaced.
  - **A.** If the vehicle is equipped with an "AM" level part, the RFHM can be reset and allow the vehicle to start and be moved around. These steps are not intended for the customer to perform but can be used until further updates can be made. This procedure is only so the vehicle can be started after the reset to allow the vehicle to be moved around the dealership property:

"A RFHM should be ordered to repair the customers vehicle. Service action for 22 WL's has been released, reference CSN (Z23).
