STAR ONLINE PUBLICATION

Case Number: S2108000270 Rev B

Symptom/Vehicle Issue: Sky Slider Power Top Does Not Operate. New Power Top Motors Inoperative

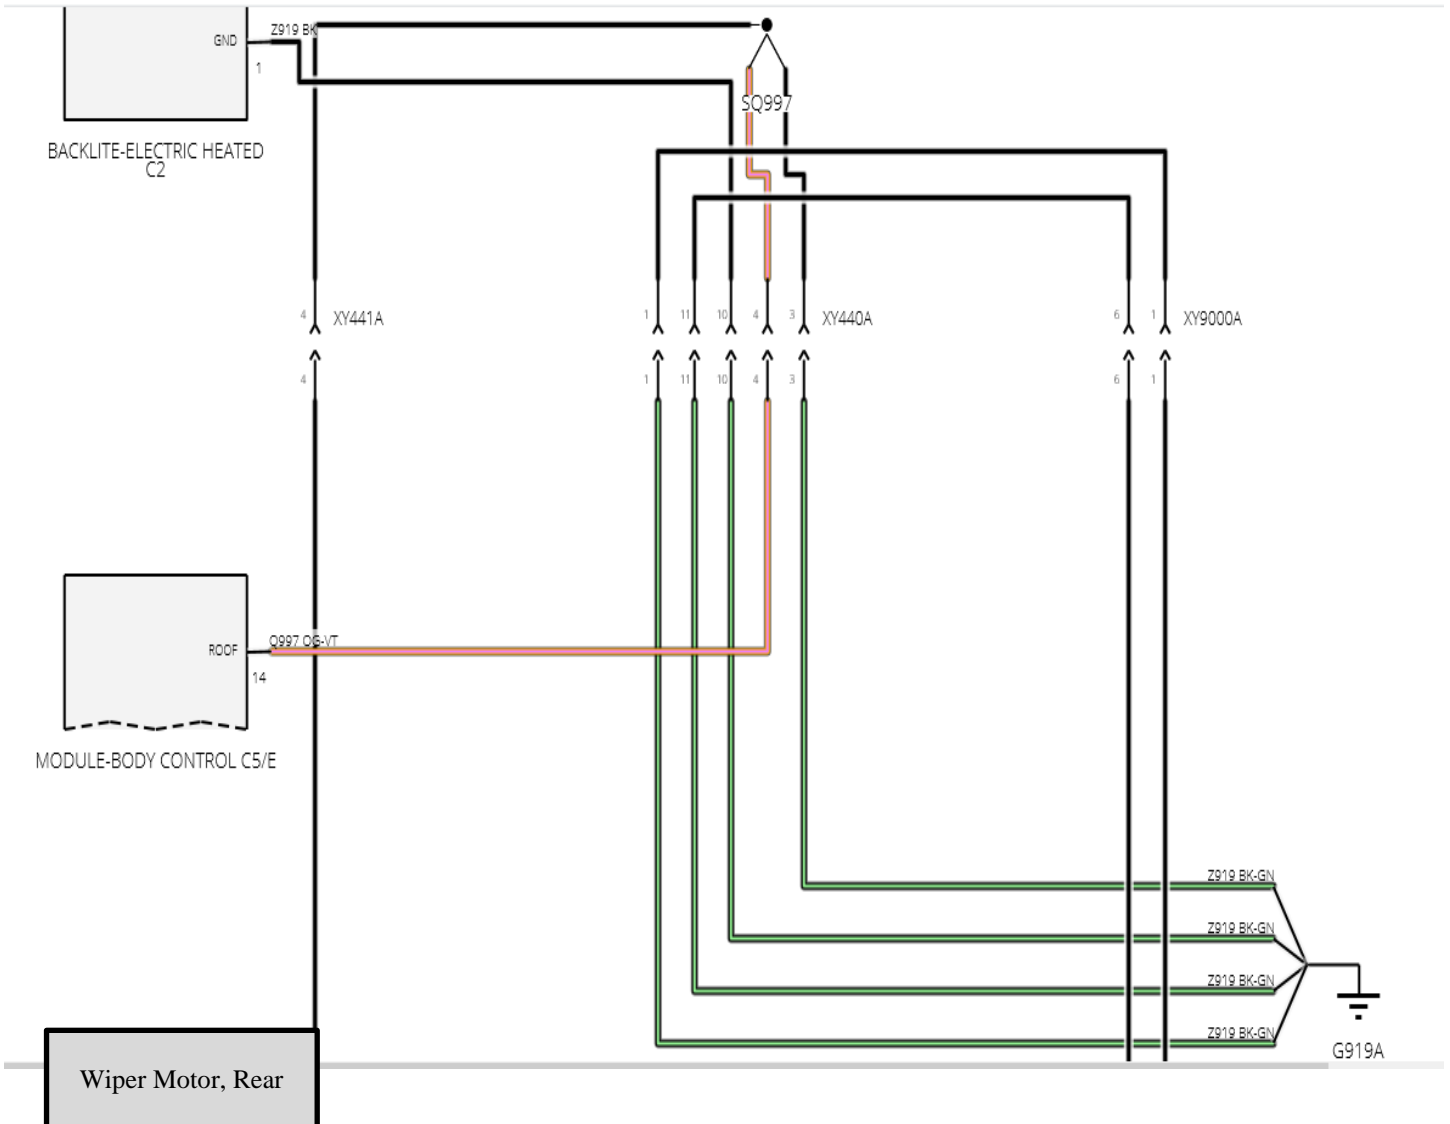
Repair Procedure: The cluster provides warning messages when ignition is first turned "on" and or during a power top open/close request. If there are no EVIC messages (see list below), check to see if the rear wiper motor will turn on. If the rear wiper does not function, check the BCM roof sense ground circuit shown in the figure below.

Check pin 14, Q997 circuit, C5 connector at the BCM for proper grounding.
