STAR ONLINE PUBLICATION

Case Number: S2208000132

Symptom/Vehicle Issue: Multiple Cluster Warning Lamps On, Malfunction Indicator Lamp (MIL) On

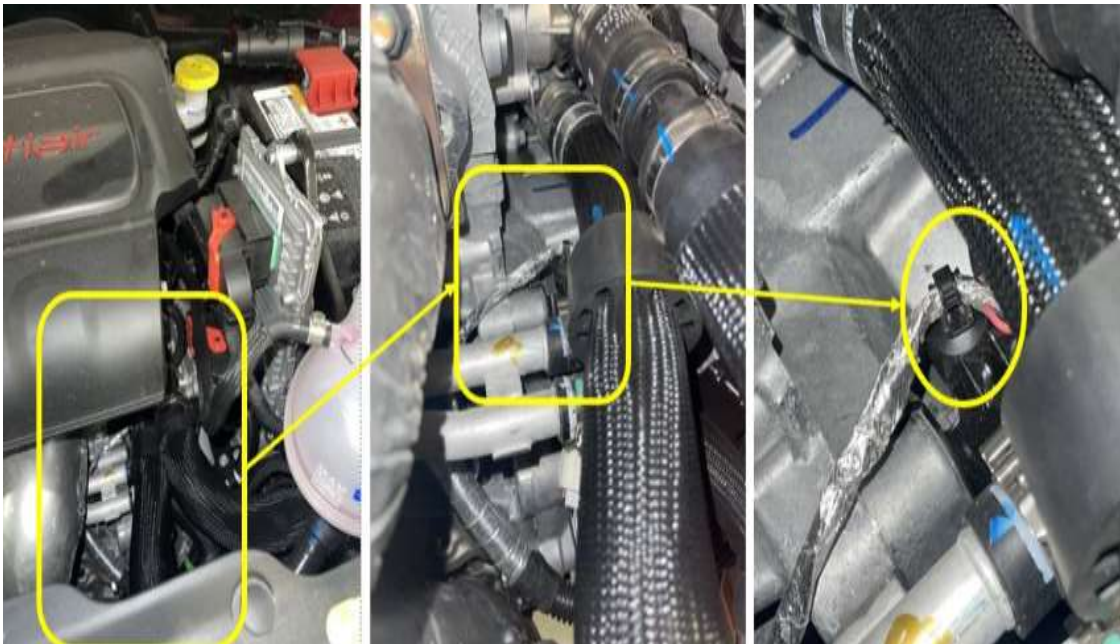
Customer Complaint/Technician Observation: Owner complaint, cluster warning lamps are on and the throttle input and vehicle speed limited, “limp mode”. Technician observed PCM Diagnostic Trouble Codes (DTC’s) **P2122 Accelerator Pedal Position Sensor 1 Circuit Low, P0335 Crankshaft Position Sensor Circuit, Sensor Reference Voltage 1 Circuit Low, U0402 Implausible Data Received from Transmission Control Module (TCM).**

Repair Procedure: Inspect the harness at the area as shown; review for chaffing, stretching, or pinching at the harness retainer. If harness damage is present, repair and isolate the harness following the standard circuit repair process. View **DealerCONNECT/Service Library, Non-DTC Diagnostics/Circuit Testing Procedures/Standard Procedure/Wire Splicing.**
