STAR ONLINE PUBLICATION

Case Number: S2223000052

Symptom/Vehicle Issue: Overhead Console Gap To Headliner

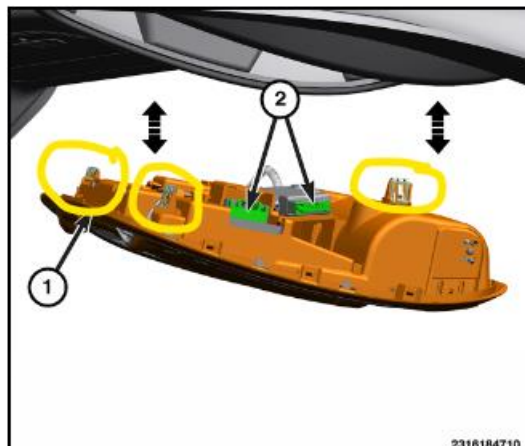
Fig 1
Mounting clip locations.

Use a trim stick at the locations of the 3 metal clips shown in Fig 1 to release the console from the roof structure.

Inspect the metal retaining clips. Address any bent or damaged clips as needed.

Begin installation by guiding the console to the roof structure and snapping in the metal clips first. Once they are all fully snapped in place, then install the 2 retaining screws.

<<<Note>>> if the screws are installed first, snapping the metal clips in will be difficult and the gap may return.

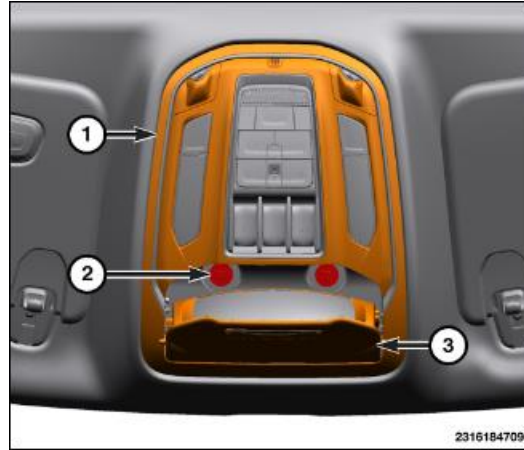
Fig 2

- 1 - Overhead Console
- 2 - Fasteners
- 3 - Sunglass Compartment

Remove the console by accessing the 2 screw fasteners in the sunglasses holder compartment (Fig 2). Remove the screws.
