Dealer Service Instructions for:

Emissions Recall U90 Catalyst Efficiency

2016 (KL) Jeep® Cherokee

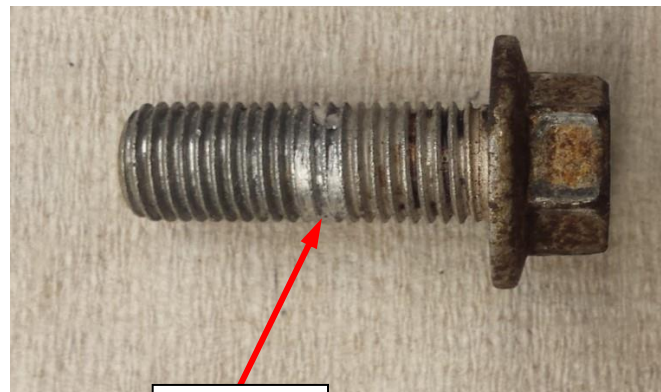
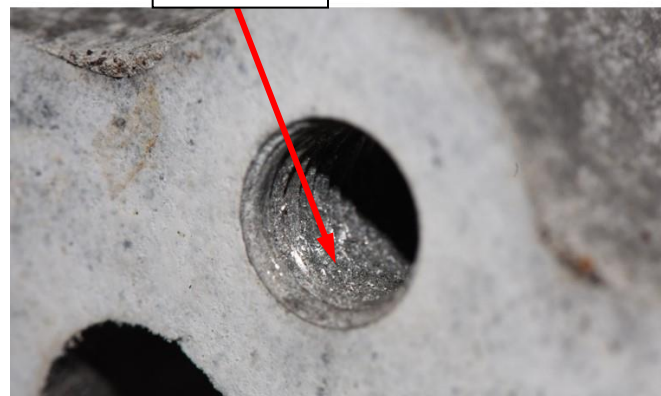
Figure 11 – Inspect for Thread Loss

NOTE: Pay attention to the bolts for signs of thread loss or bolt breakage as they are removed and note which hole they came from (Figure 11).

18. Inspect the bolts and bolt holes for any signs of thread loss then **DISCARD** the bolts (Figure 11).

- If bolt holes do not show signs of thread loss, proceed to **Step 21**.
- If bolt holes show signs of thread loss, continue with **Step 19**.
- If a bolt is broken off in the hole, proceed to **Step 20**.

19. If thread loss is suspected, use compressed air to remove any debris from the suspect bolt hole. With the old maniverter and gasket still in place on the engine head, install a **NEW** exhaust manifold bolt in the suspect hole and tighten the bolt to 34 N·m (25 ft. lbs.) to determine if proper torque can be achieved.

- If the bolt is able to be tightened to 34 N·m (25 ft. lbs.), no further action is required. Remove the bolt and proceed to **Step 21**.
 - If the bolt hole threads are stripped allowing the bolt to rotate, unable to achieve proper torque, remove the bolt and continue with **Step 20**.

20. For stripped hole(s) or broken bolt(s), submit a collateral damage claim to obtain authorization for installing a helicoil in the damaged hole(s). Remove the maniverter and gasket following **Steps 21 - 23**. Then use the special tool **2073500090 - Kit, Cylinder Head Thread Repair - 2.4L MAIR** to perform the helicoil thread repair operation by following the service instructions published in **DealerCONNECT / Service Library / Engine, 2.4L Multiair / Standard Procedure / Exhaust Manifold Fastener Hole Repair**. After the damaged bolt hole(s) have been repaired with helicoil(s), proceed with **Step 24**.
