NUMBER: 08-116-22

Power Inverter Wiring Hanging Below the Instrument Panel Cowl on the Drivers Side

2022 (JT) Jeep Gladiator

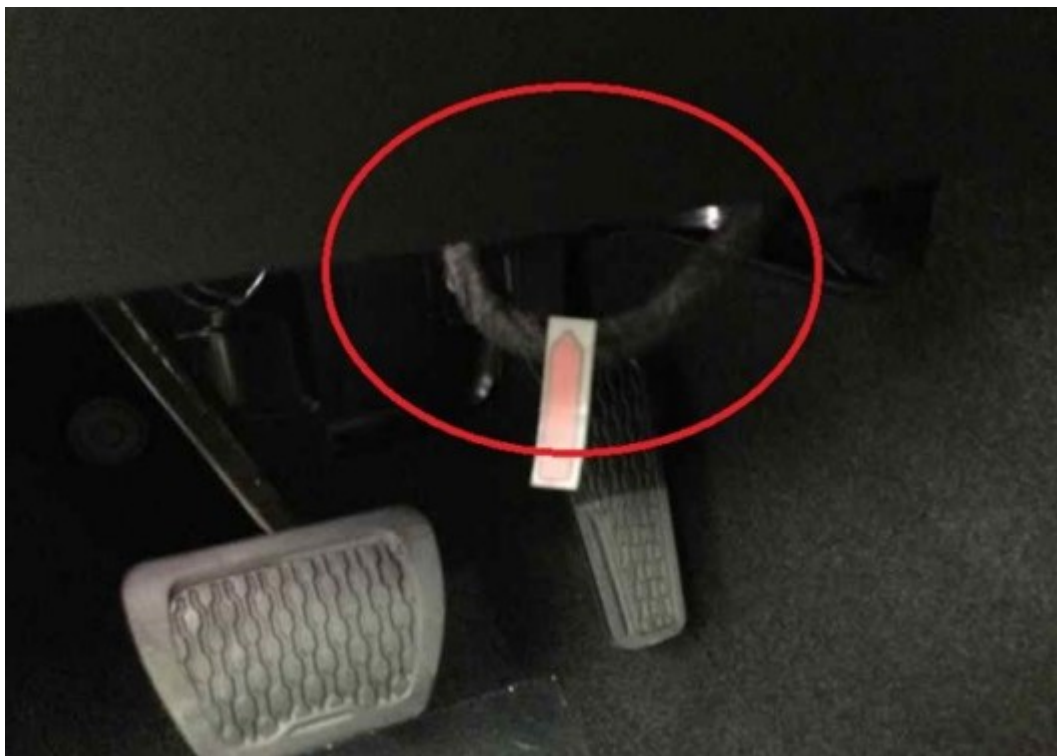
Fig. 1
Wire Hanging

Customers may experience a loose wire harness hanging below the steering column and the panel on the driver's side (Fig. 1) .
