NUMBER: 08-062-22 REV. B

UPD UFD UBD UED UBC UEC Radio Enhancements

This bulletin involves inspecting the software level and updating the software if needed. The software will be updated to 141.01.12.00.

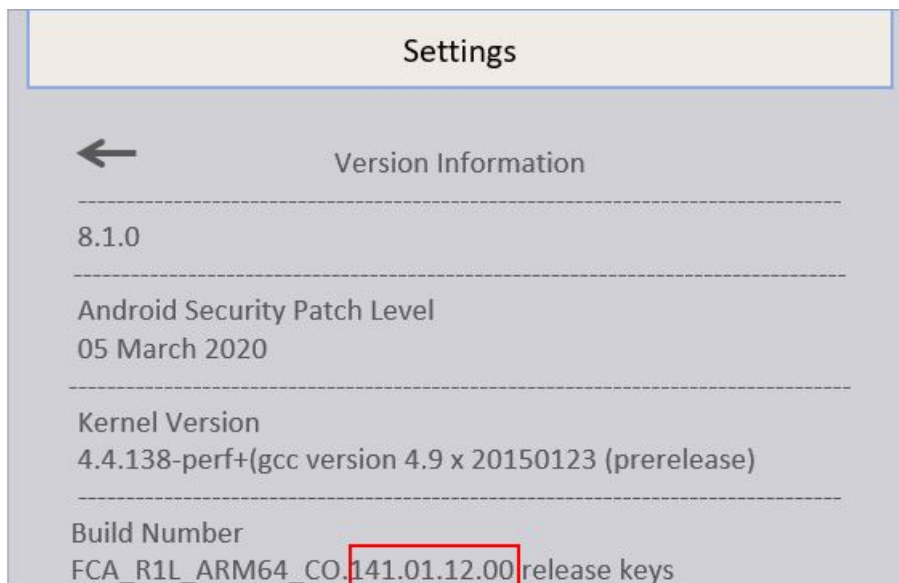
Fig. 1

1. On the radio display screen go into "Vehicle Settings".
2. Select "System Information".
3. Select "Version Information".
4. Under the "Build Number", radio software version is listed. For example, the software version here is 141.01.12.00 (Fig. 1) .

Radio Software Level Screen

5. Is the software compatible for the update?
 - YES>>> The software version is below 141.01.12.00. Proceed to [Step 1](#) of the repair procedure below.
 - NO>>> If the software version is at or above 141.01.12.00, the radio is already at updated software. This bulletin has been completed, Use inspection LOP (18-60-02-9R) to close the active RSU.

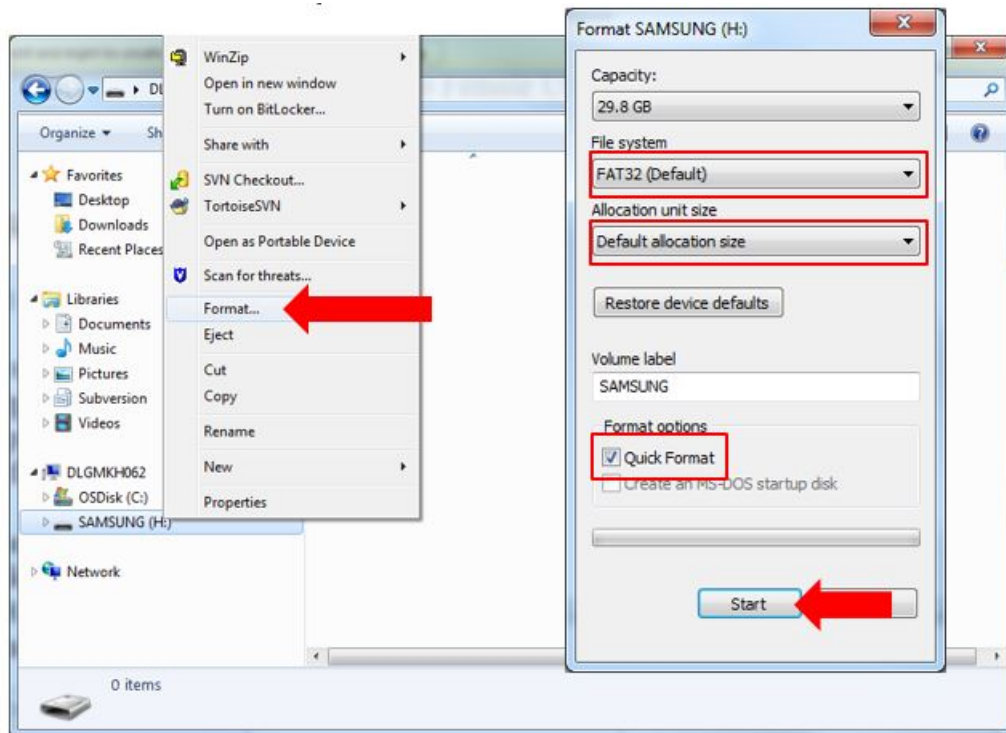
Fig. 2
Formatting The USB Flash Drive

1. Reprogram the radio with the latest software 141.01.12.00 via USB.
2. Has a **4 GB** USB flash drive been created?
 - YES >>> Proceed to [Step 13](#).
 - NO >>> Proceed to [Step 3](#).
3. Perform the following steps to format the USB flash drive ([Fig. 2](#)) .
 - a. Select “FAT32” format.
 - b. Select “Default allocation size” under Allocation Unit Size.
 - c. Select “Quick Format” under Format Options.
 - d. Click “Start”.

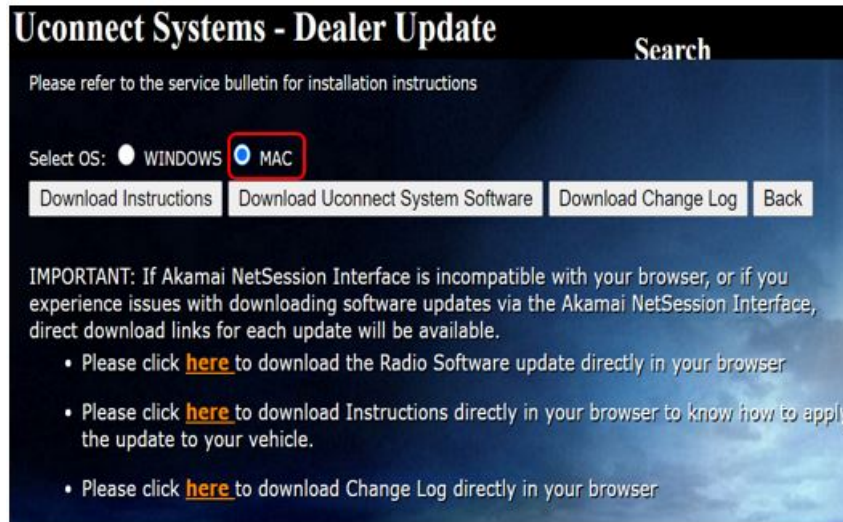
Fig. 3
MAC Download Steps

5. Use a blank USB flash drive with at least 4 GB of space. Follow the on-screen instructions to download the software files.
6. Download the software update file to your local PC's desktop. Make sure to select the "MAC" radial button for all downloads (Fig. 3) .

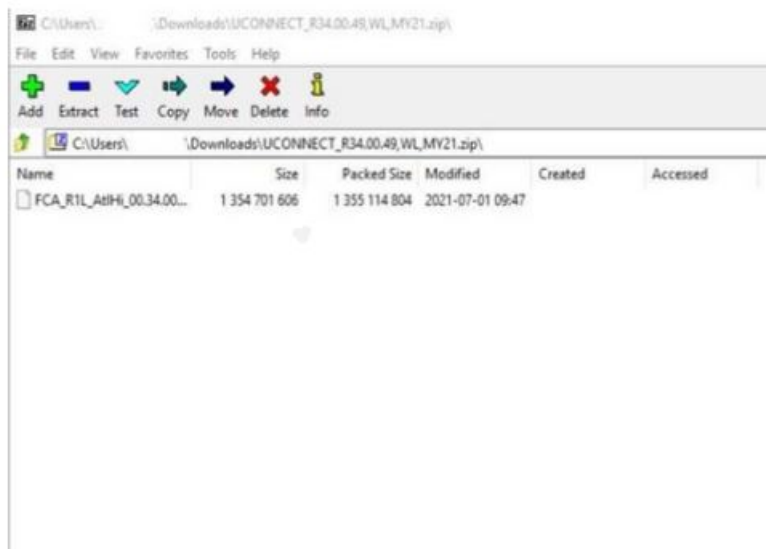
Fig. 4
Zip File

7. Be sure to download the file to your designated folder before extracting the zip file to the blank USB flash drive (Fig. 4) .

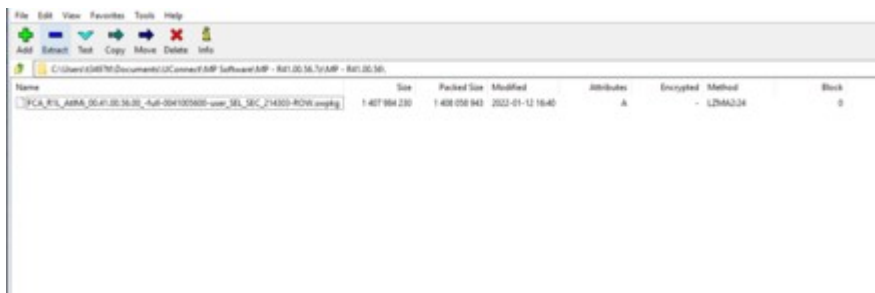
Fig. 5
Extract File To USB

- 8. Unzip the file to the root folder of USB flash drive. File should not be within a zip folder. Your USB file should look like when you open it. (Fig. 5) .

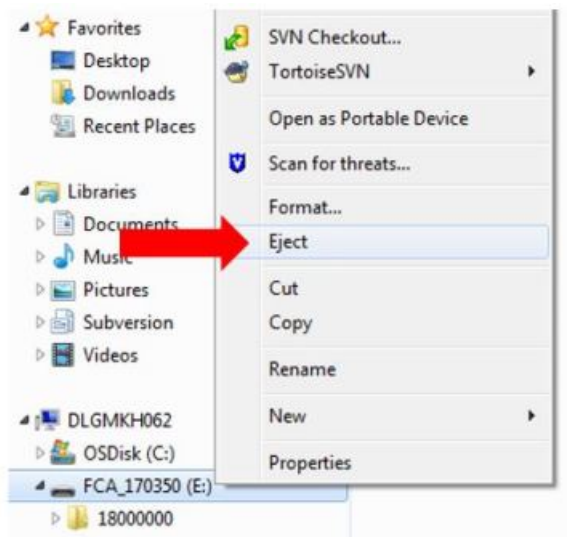
Fig. 6
Ejecting The USB Flash Drive

- 10. Perform the following steps to properly eject the USB flash drive (Fig. 6) :
 - a. Right click on the location of the USB flash drive.
 - b. Click “Eject” to avoid data corruption.
 - c. Remove the USB flash drive from the PC.

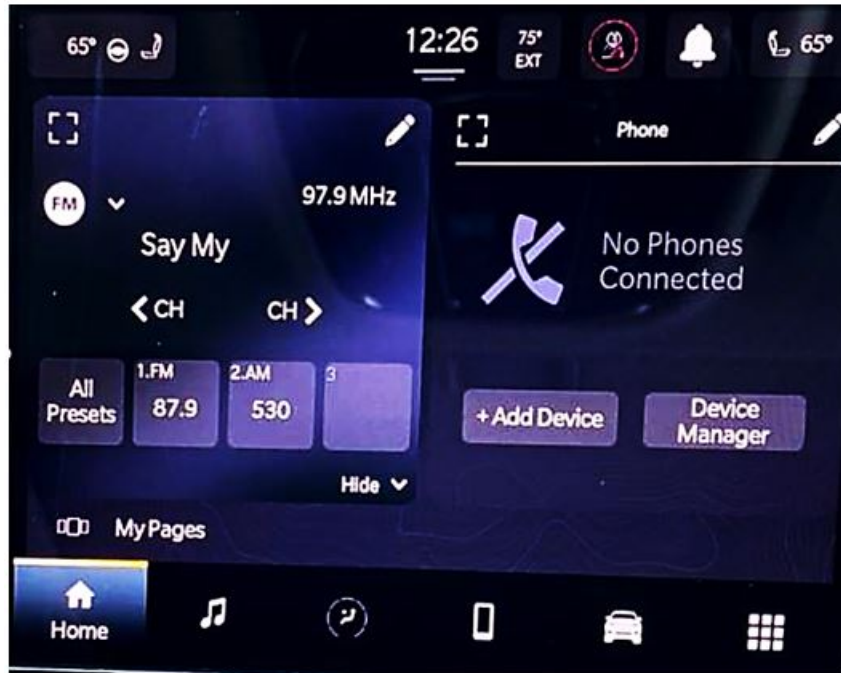
Fig. 7
Home Screen

13. Start the vehicle and insert the USB flash drive into the USB port.
14. Vehicle must be out of “Ship Mode”. Starting at the radio ‘Home’ screen (Fig. 7) .

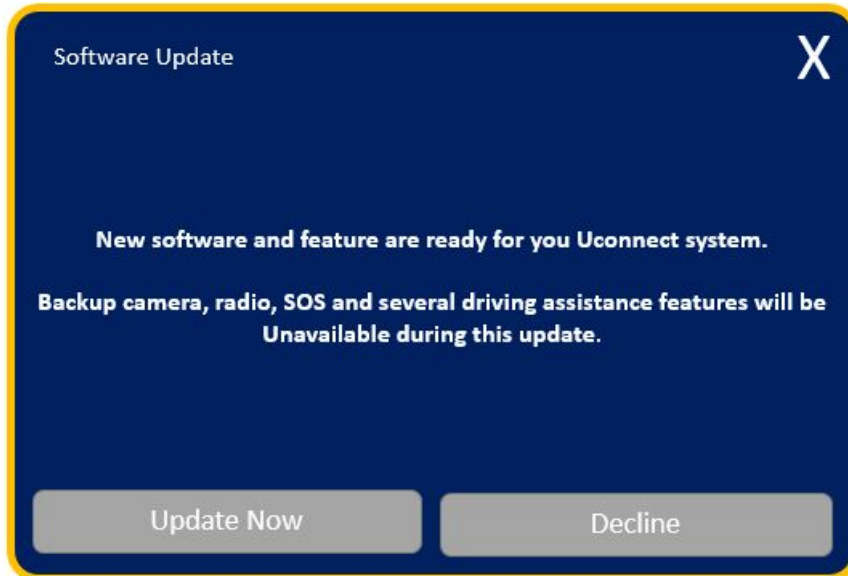
Fig. 8
Software Update Screen

16. The radio will prompt you if you want to update to the newest software version (Fig. 8) .

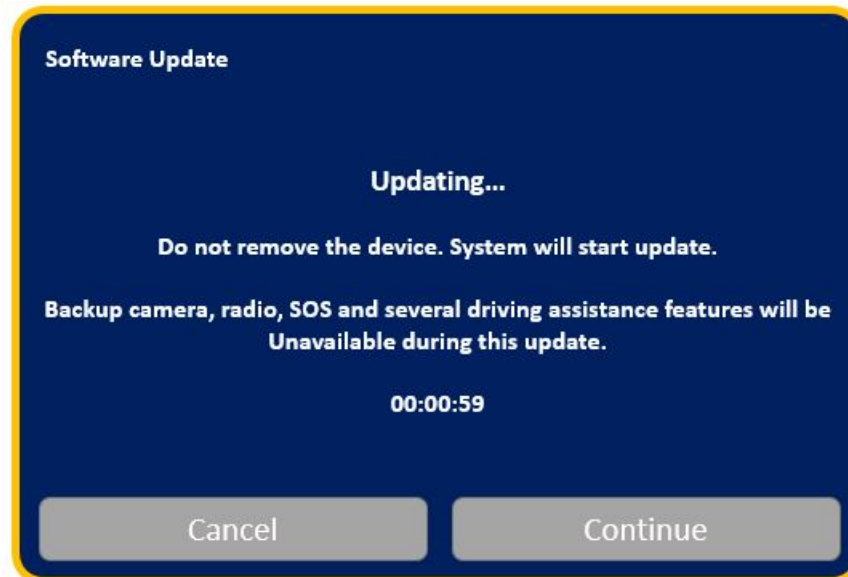
Fig. 9
Software Updating Screen

18. The radio will prompt you if you want to continue updating to the newer software (Fig. 9) .

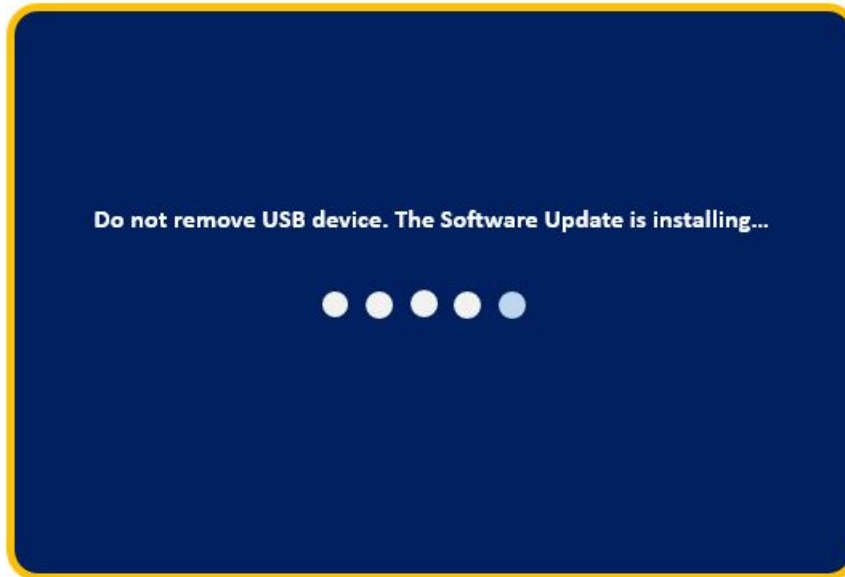
Fig. 10
Installing Update Screen

19. Select "Continue" (Fig. 10) .

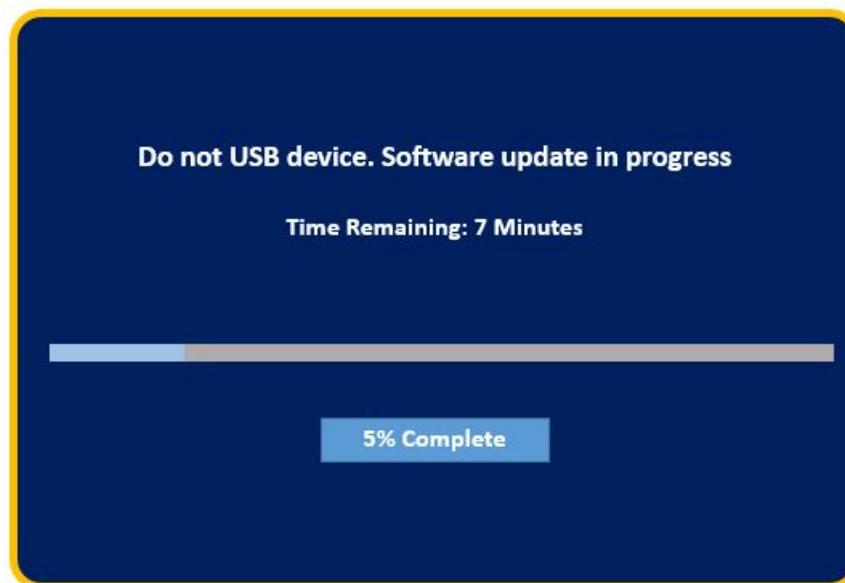
Fig. 11
Update In Progress Screen

20. The update will take approximately 15-20 minutes (Fig. 11) .

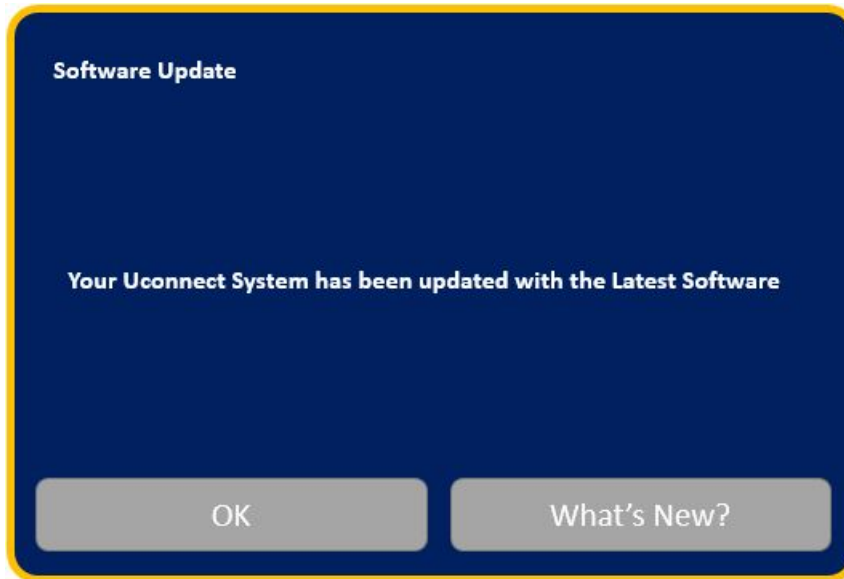
Fig. 12
Software Updated Screen

21. The radio will reboot and you will observe the update screen after the splash screen once the update has been successful (Fig. 12) .

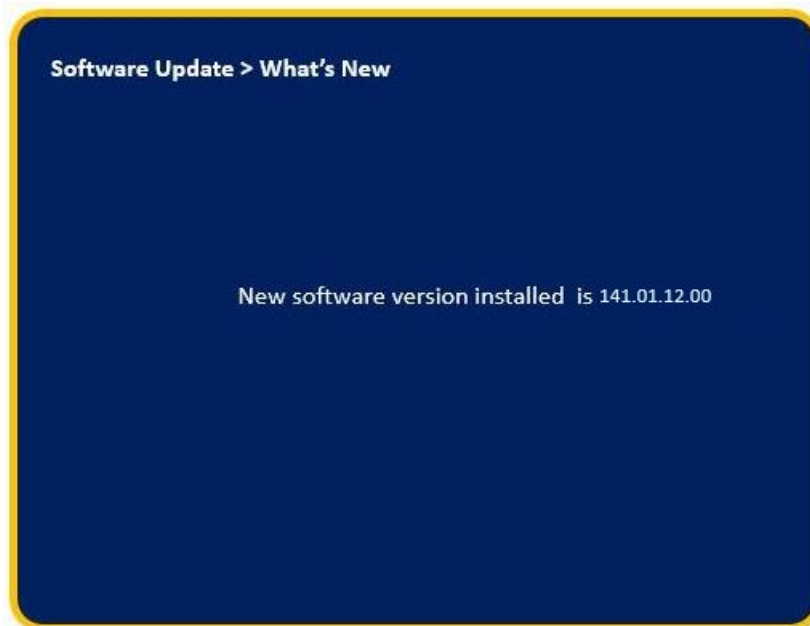
Fig. 13
What's New Screen

22. Select "What's new" to confirm the software has been updated to 141.01.12.00 (Fig. 13) .
