NUMBER: 08-121-22

GROUP: 08 - Electrical

Radio Over The Air Software Version Updates

2022	(WL)	Jeep Grand Cherokee
2022	(WS)	Wagoneer/Grand Wagoneer
2022	(RU)	Chrysler Pacifica/Voyager

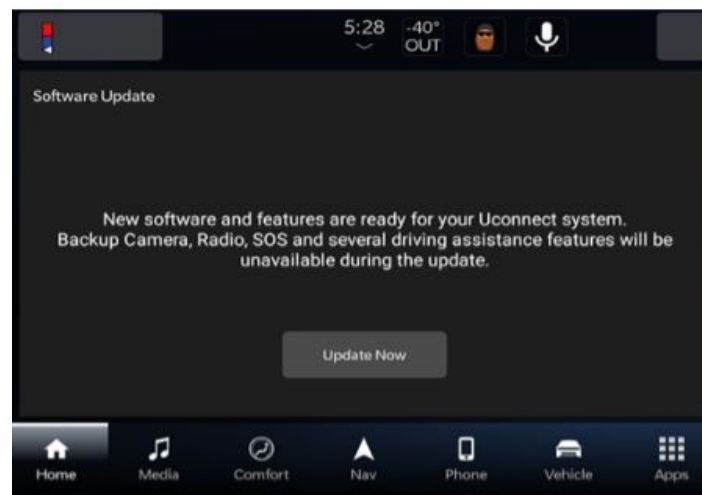
Fig. 1
Software Acceptance Screen

1. The vehicle needs to be in 'park'. The ignition needs to be in the off position.

2. If the customer selects “Update Now” they can shut off the vehicle and leave. The update will be completed automatically.

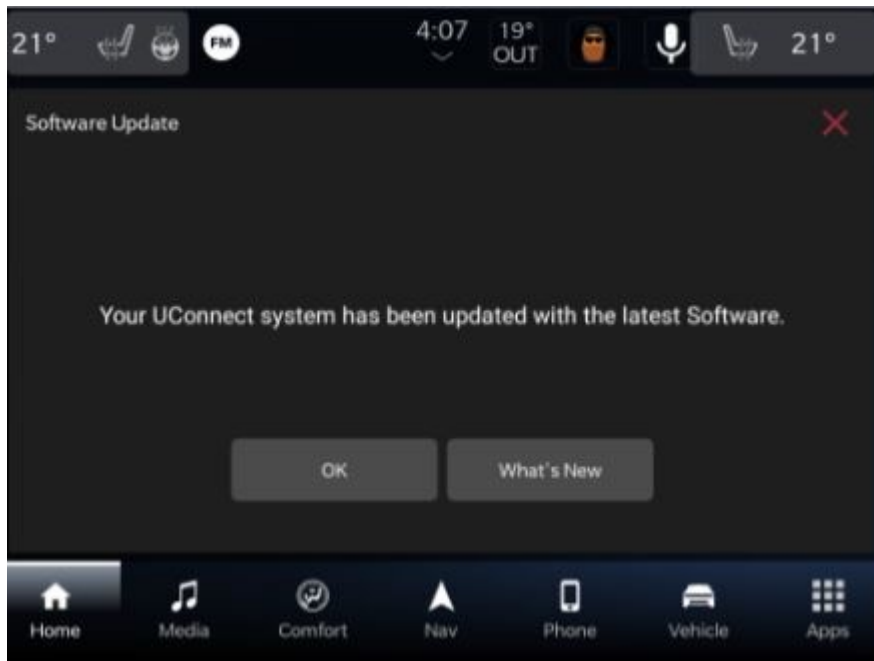
Fig. 2
Software Update Confirmation Screen

3. Upon completion of update, the radio will display a confirmation message (Fig. 2) .
