**NUMBER:** 23-024-22

**DATE:** June 22, 2022

Headlamp Condensation Clearing Procedure

This bulletin is to communicate the procedure for headlamp condensation clearing.

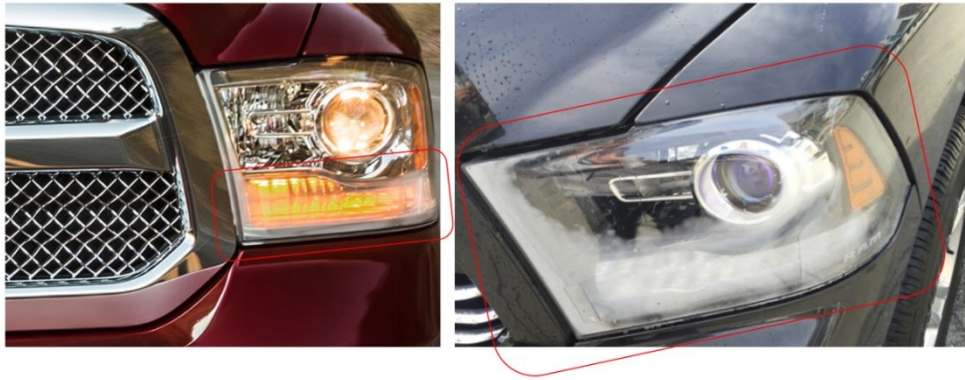
Some customers may report that on occasion, vehicle exterior headlamp assemblies are fogged with a light layer of condensation on the inside of the lenses (Fig. 1). This may be reported after the lamps have been turned on and brought up to operating temperature, turned off, and then rapidly cooled by cold water (such as rain, or the water from a vehicle wash). Lens fogging can also occur under certain atmospheric conditions after a vehicle has been parked outside overnight (i.e., a warm humid day followed by clear cool night). This will usually clear as atmospheric conditions change to allow the condensation to change back into a vapor. Turning the headlamp on will usually accelerate this process.

**Fig. 1**  
**Fogged Headlamps**

A lamp that exhibits condensation/fogging should be evaluated in a service bay environment according to the following steps:

1. Dry all water from the outside surface of the lens.
2. Operating the lamps for 20 minutes by:
  - Starting the vehicle engine.
  - Turning on the vehicle lights and turn on the hazard lights.

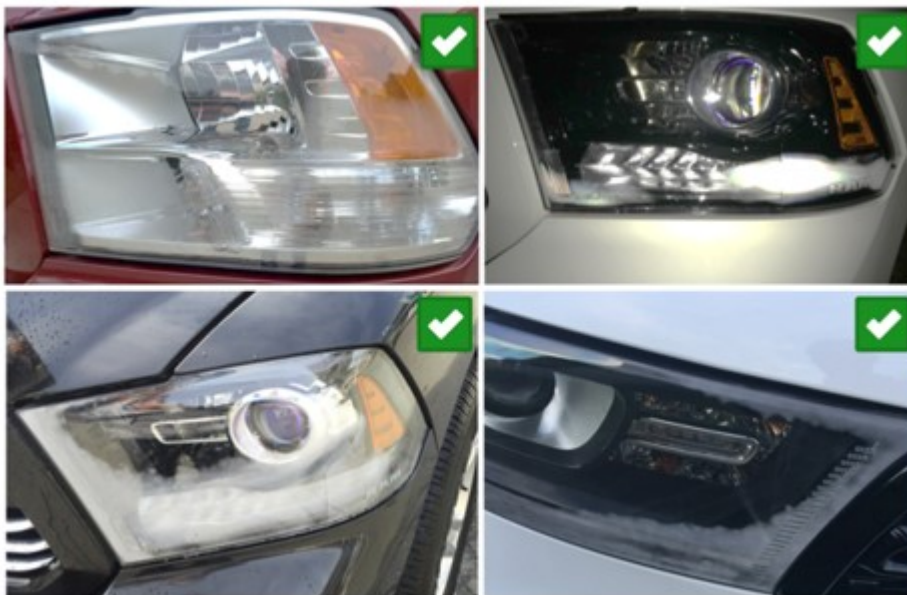
If the condensation/fogging has begun to clear (Fig. 2) from the lamp lens after 20 minutes with the lamps operating, this indicates the lamp sealing has not been breached, and the lamp does not need to be replaced.

**Fig. 2**  
**Condensation/Fogging Begun To Clear**

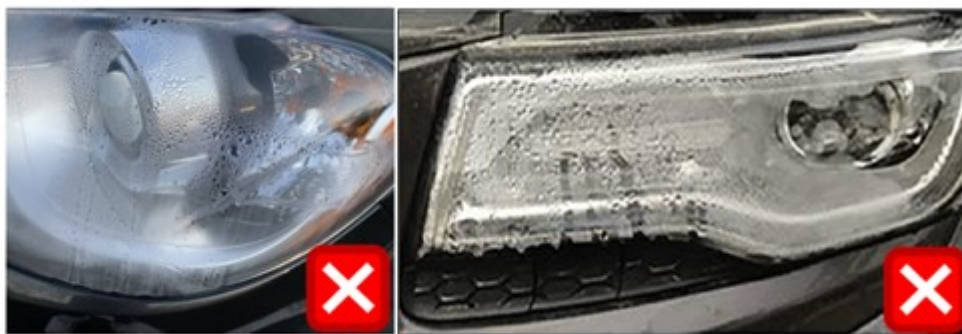
If the condensation/fogging has not begun to clear after 20 minutes with the lamps operating, or the lamp has large amounts of water droplets visible on most internal surfaces, this indicates a problem with the lamp sealing that has allowed water to enter the lamp. In this instance, the customer is also likely to report that moisture in the lamp is always present and never disappears. A lamp that exhibits internal moisture permanently should be replaced.

Fig. 3  
Condensation/Fogging Not Begun To Clear

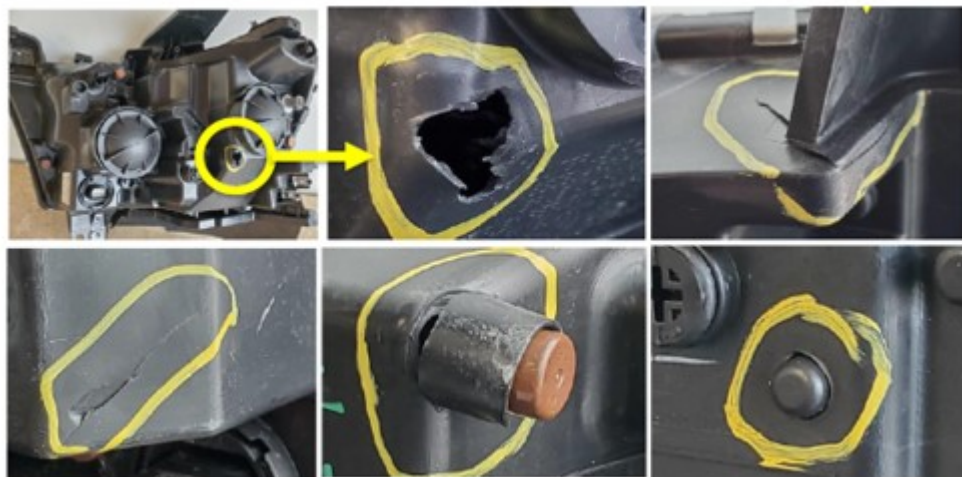
- **Damage:** Breakage on the headlamp housing will allow moisture/water to enter to the headlamp (damage, cracks, holes, etc.) (Fig. 4) . If this is noticed the failure code must be recorded accordingly: **11/BROKEN OR CRACKED**

Fig. 4  
Cracked or Broken Headlamps

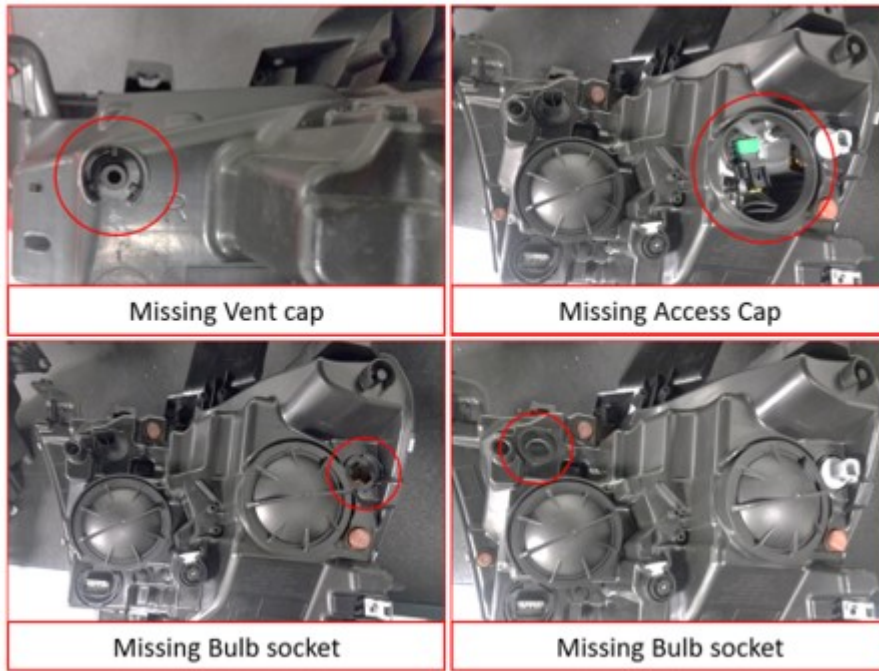
- **Missing Sealing Components:** Missing vent caps, access caps or bulb sockets will allow moisture/water to enter to the headlamp (Fig. 5) . If this is noticed the failure code must be recorded accordingly: **1C / CONNECTOR LOOSE NOT ATTACHED**
- **Misplaced Sealing Components:** Misplaced vent caps, access caps or bulb sockets will allow moisture/water to enter to the headlamp (Fig. 6) . If this is noticed the failure code must be recorded accordingly: **1C / CONNECTOR LOOSE NOT ATTACHED**

**Fig. 5**  
**Missing Sealing Components**

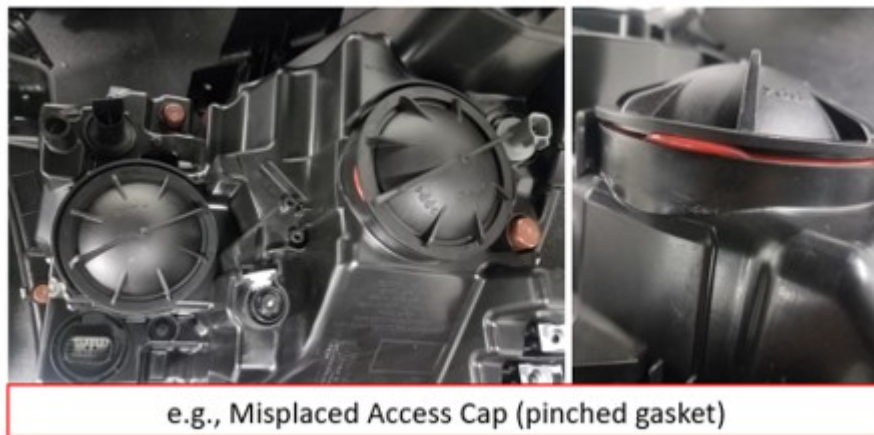
**Fig. 6**  
**Misplaced Sealing Components**
