**NUMBER:** 08-127-22

Rear Wiper Inoperative

This bulletin involves inspecting and if necessary repairing a bent electrical pin in the inline connector between the left body harness and the liftgate harness.

2022 (RU) Chrysler Pacifica

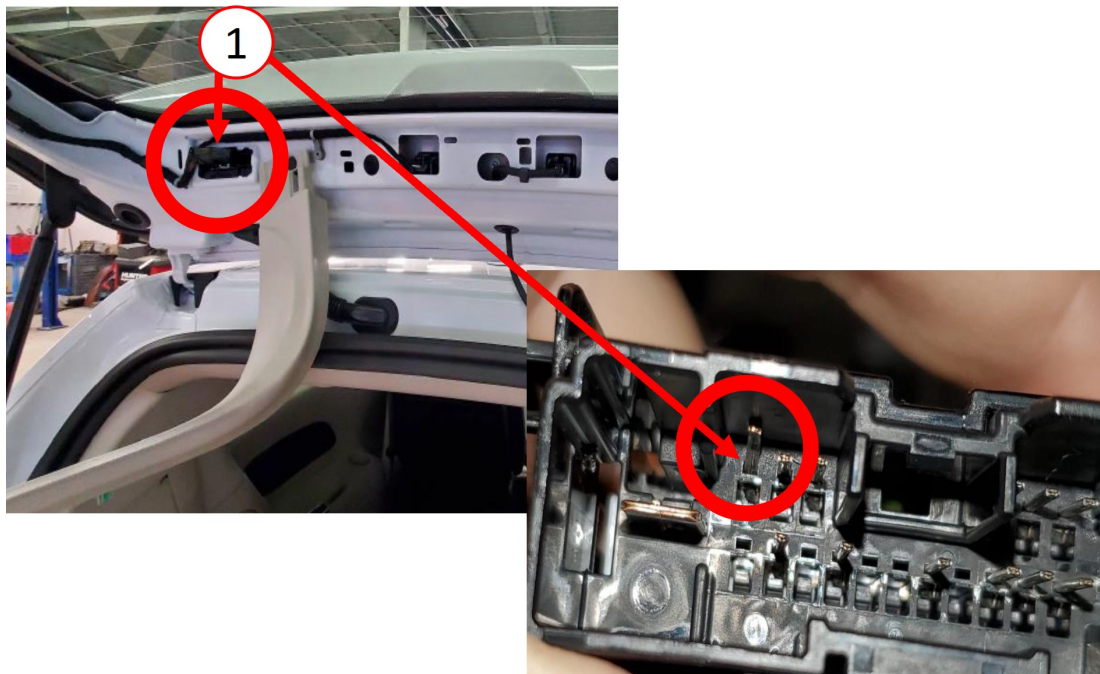
**Fig. 1**

**Bent Pin in the Connector at XY550A (Pin 2 Circuit W13 Rear Wiper Motor Control)**

1 - Bent Pin Location, Pin 2 Circuit W13 Rear Wiper Motor Control.

5. Inspect the connector on the lift gate for a bent pin at XY550A.
6. Was the pin bent at XY550A ([Fig. 1](#)) ?
  - YES>>> Proceed to [Step 7](#).
  - NO>>> This Bulletin does not apply. Normal diagnosis should be performed, use inspect LOP (08-91-WB-90) to close the active RSU.
7. Straighten the bent pin ([Fig. 1](#)) .
8. Reconnect the harness to the electrical connector.
9. Verify the rear wiper operation.
10. Does the rear wiper operation function properly?
  - YES>>> Proceed to [Step 11](#).
  - NO>>> This Bulletin does not apply. Normal diagnosis should be performed, use inspect LOP (08-91-WB-90) to close the active RSU.
