NUMBER: 08-062-22 REV. C

UPD UFD UBD UED UBC UEC Radio Enhancements

This bulletin involves inspecting the software level and updating the software if needed. The software will be updated to 141.01.12.00.

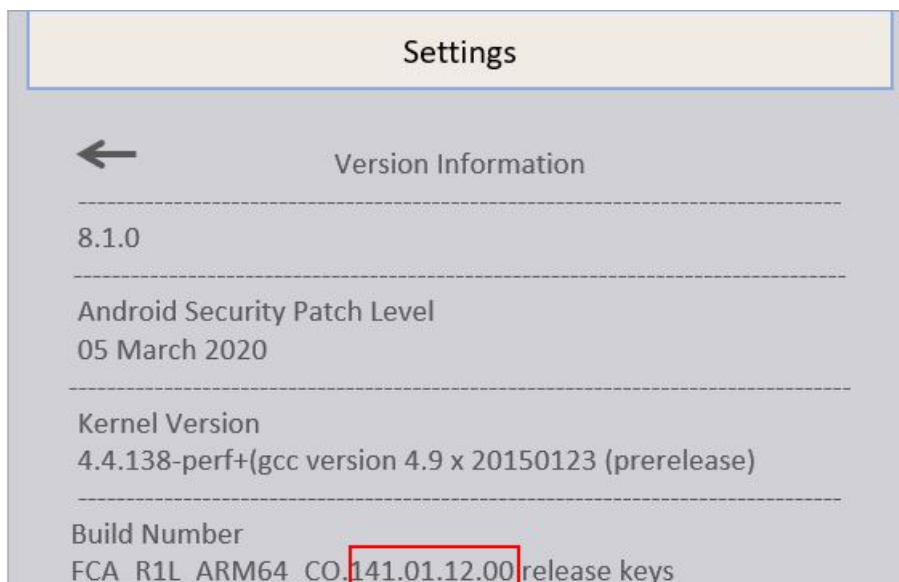
Fig. 1
Radio Software Level Screen

1. On the radio display screen go into "Vehicle Settings".
2. Select "System Information".
3. Select "Version Information".
4. Under the "Build Number", radio software version is listed. For example, the software version here is 141.01.12.00 (Fig. 1) .

5. Is the software compatible for the update?
 - YES>>> The software version is below 141.01.12.00. Proceed to [Step 1](#) of the repair procedure below.
 - NO>>> If the software version is at or above 141.01.12.00, the radio is already at updated software. This bulletin has been completed, Use inspection LOP (18-60-02-9R) to close the active RSU.
