HYUNDAI Technical Service Bulletin	GROUP CAMPAIGN	NUMBER 22-01-077H
	DATE SEPTEMBER 2022	MODEL(S) Tucson (NX4)
SUBJECT: D-AUDIO SOFTWARE UPDATE: VOLUME UNAVAILABLE (SERVICE CAMPAIGN T9D)

Description: This bulletin describes the procedure to correct vehicles that are experiencing Bluelink/Bluetooth volume unavailability.

Applicable Vehicles: Certain 2022MY Tucson (NX4) produced from 11/09/2021- 04/18/2022

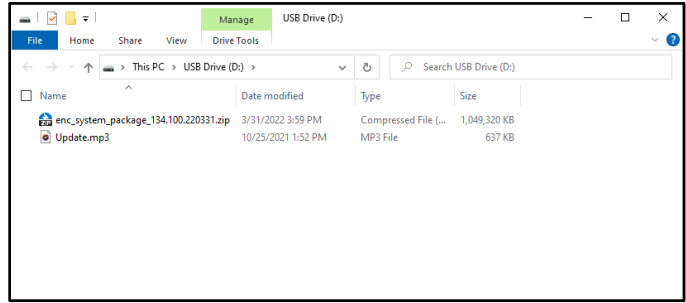
This is to distinguish when the update does not work due to file corruption or a faulty USB.

If the MP3 file plays and the update fails, the file is corrupt.

If the MP3 file does not play and the update fails, the USB is faulty.

- 6. The USB drive has an MP3 file that will play automatically when USB is plugged into the slot.

Press the **UPDATE** button at the bottom of the screen to proceed with the software update.

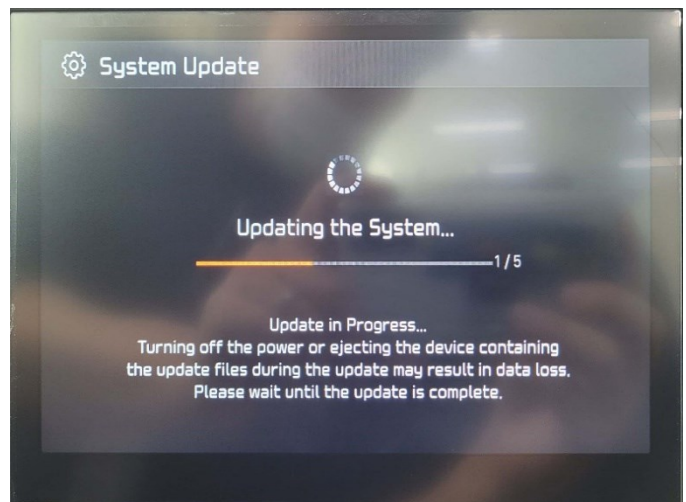
There will be multiple occurrences where the Hyundai logo will appear, or the display will be black, during the update process. This is normal.

- 7. The update is done automatically, so please wait until the update is complete. (Approximate time ~ 15 minutes).

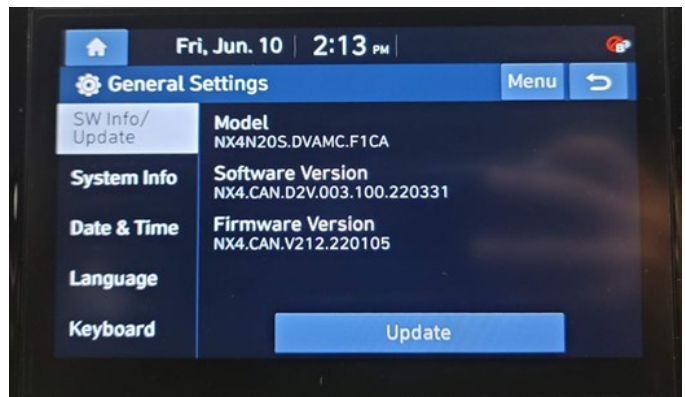
Picture to the right is updated version for a Canadian vehicle; the updated version will say USA instead of CAN for a USA vehicle.

9. After the system restarts, confirm the S/W version has been correctly updated by referring to the **SW INFO/UPDATE** screen (See steps 1- 4 above).

Updated S/W version ends in 003.100.220331.

Remove the USB memory stick from the vehicle.
