HYUNDAI Technical Service Bulletin	GROUP CAMPAIGN	NUMBER 22-01-076H
	DATE SEPTEMBER, 2022	MODEL(S) Elantra (CN7, CN7a) Elantra Hybrid (CN7 HEV)
SUBJECT: ICU (INTEGRATED CENTRAL CONTROL UNIT) SOFTWARE UPDATE (SERVICE CAMPAIGN T8T)

**SUBJECT: ICU (INTEGRATED CENTRAL CONTROL UNIT) SOFTWARE UPDATE
(SERVICE CAMPAIGN T8T)**

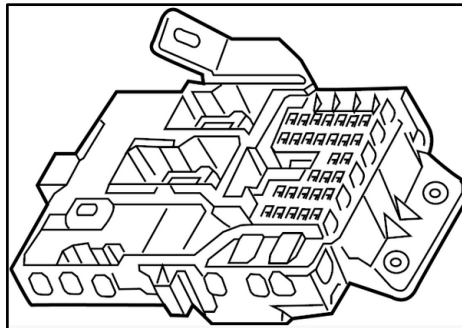
Description: Some 2021 ~ 2022MY Elantra (CN7, CN7a, CN7 HEV) vehicles may exhibit a condition with multiple warning lights displayed on the instrument cluster and various symptoms; multiple DTCs (Diagnostic Trouble Code), reduction in power steering assist, and not able to shift out of Park. Possible DTCs set are:

- C181287 – CAN Time-out Gateway
- C181208 – CAN Time-out Gateway
- C180581 – LKAS CAN Signal Error
- C181887 – CAN Time-out BCA
- B109052 – TCU Missing Error

This bulletin provides the service procedure to update the ICU (Integrated Central Control Unit) software to resolve the conditions stated above.
