01-22-05 - Update Programming Engine/Motor Control Module - J623- for Various Concerns

Release date: 9/22/2022

Applicable Vehicles					
Model(s)	Year	Eng. Code	Trans. Code	VIN Range From	VIN Range To
Taos	2022	1.5T (DNKA)	All	All	All
Jetta	2022	1.5T (DNKA)	All	All	All

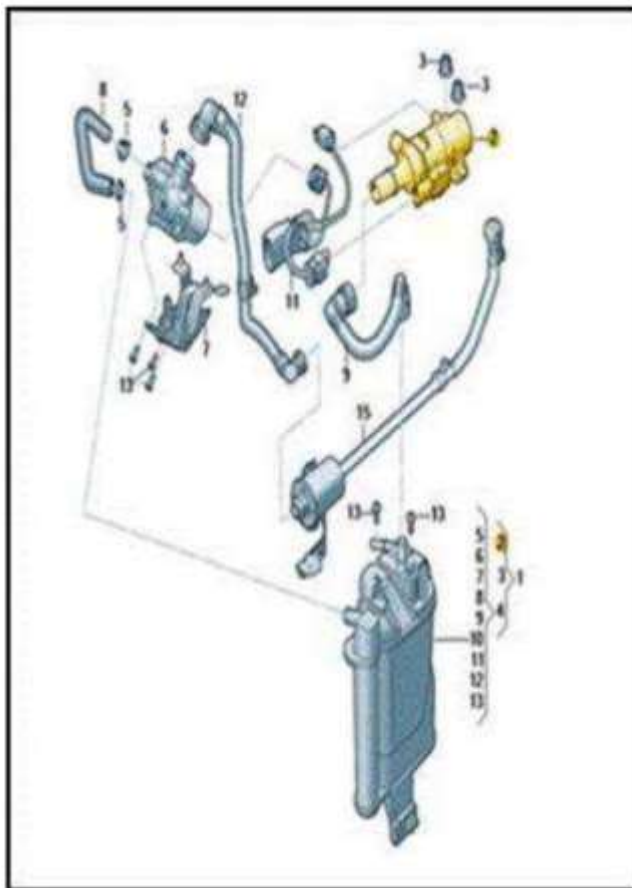
Figure 1.

In addition to the software improvement, there is also an improvement to the FTIV (fuel tank isolation valve/tank switch-off valve -**N288**-) (Figure 1.), which is necessary in preventing erroneous occurrences of the P2421 fault code.

The FTIV / Tank switch-off valve -**N288**- currently installed on the vehicle must be inspected, to verify whether an improved part has already been installed. The FTIV / Tank switch-off valve -N288- is mounted to the EVAP canister assembly, as shown below.

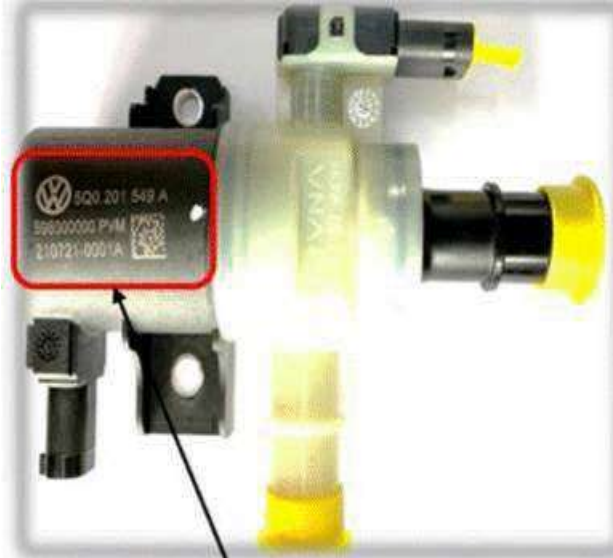
Figure 2.

Remove the EVAP canister assembly and inspect the face of the FTIV / Tank switch-off valve -**N288**-. If the part is already updated, it will have a white paint marking or "02S" printed after the part number, as shown in Figure 2 and Figure 3.

- If the part has a white paint mark or "02S", the FTIV / Tank switch-off valve -N288- is already the updated component. In this case DO NOT replace it, and instead reinstall the EVAP canister assembly. Only the software update will be required.

- If there is no white paint mark or “02S” visible on the FTIV / Tank switch-off valve -**N288**-, the component must be replaced in addition to the software update. Always refer to ETKA for the most up to date part number information.
