# Technical Service Bulletin

## 91 No diagnostics communication to the telematics control module

91 22 30 2056076/16 September 23, 2022. Supersedes Technical Service Bulletin Group 91 number 22-25 dated September 14, 2022, for reasons listed below.

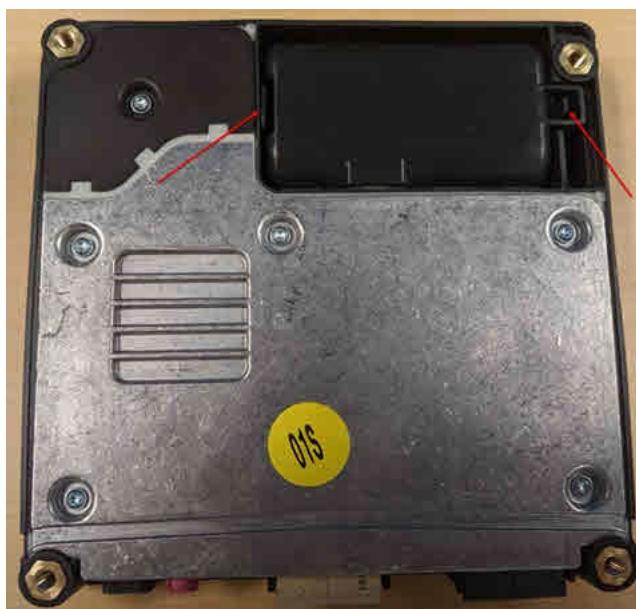
*Figure 2. Backup battery compartment location.*

1. Remove and unplug the telematics control module, J949 (address word 0075) according to the Elsa Repair Manual.
2. Open the battery compartment of the telematics control module, J949 (address word 0075), and disconnect the backup battery (Figures 2 - 3).

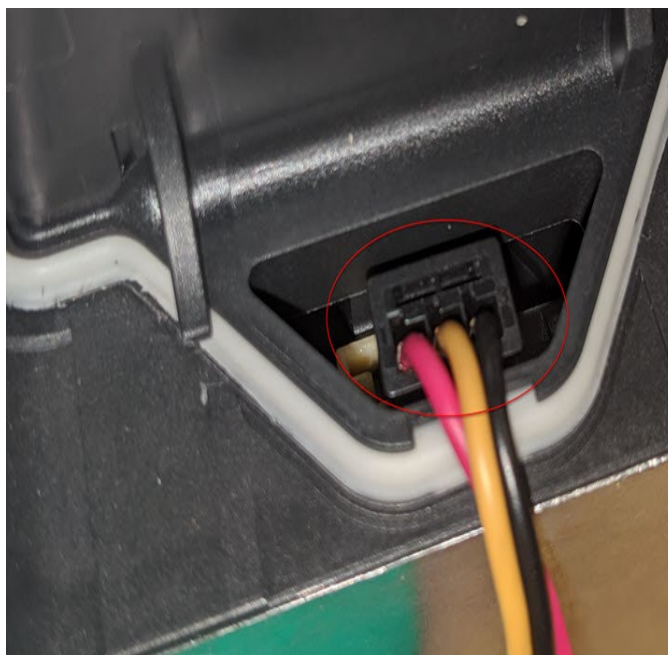
**Figure 3.** Backup battery connector (no release mechanism).
