Technical product information

Topic	New Continental GT and GTC - Window drop glass concerns
Market area	Russische Föderation (5RU),Australia E04 Bentley rest Asia and Australia (6E04),China 796 VW Import Comp. Ltd (Vico), Beijing (6796),Germany E02 Bentley rest Europe (6E02),Japan E03 Bentley Japan (6E03),Korea, (South) E08 Bentley South Korea (6E08),United Arab Emirates E06 Bentley Middle East and Africa (6E06),United Kingdom E01 Bentley UK (6E01),United States E05 Bentley USA and rest America (6E05)
Brand	Bentley
Transaction No.	2067436/2
Level	EH
Status	Released for publishing
Release date	14-Sep-2022

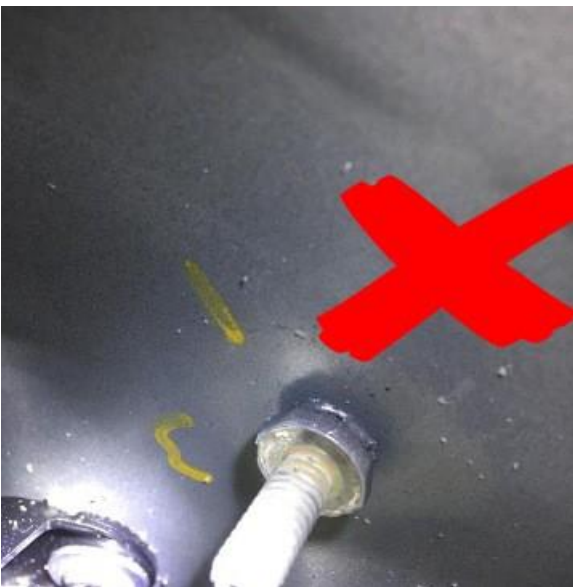
- Earth point 736 RHR and Earth point 738 LHR
- Check for cleanliness and security of both earth points Figure 2 shows an example of a contaminated earth point (dirt/paint/debris)

- Remove any dirt/paint/debris from the earth points using suitable abrasives/wire brush ensuring no damage is caused to the earth stud threads as shown in Figure 3

- Secure the earth point fixings to

(9Nm) Comments

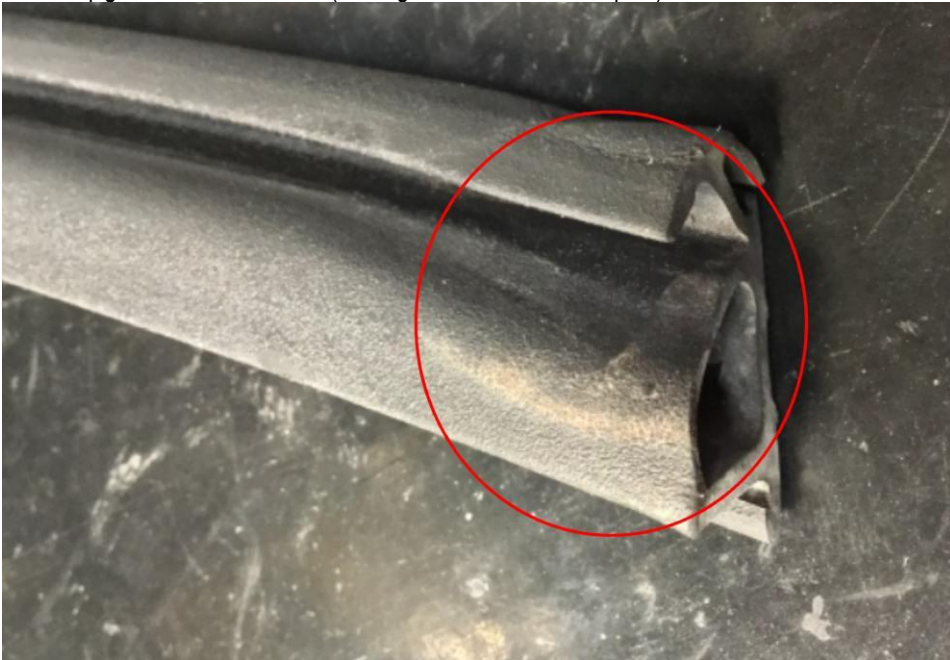
Figure 4

- Damage
- Splits
- Tears
- Misalignment
- Incorrectly fitted/located
- Drop glass seal deformation (see Figures 4 and 5 as examples)

NOTE: Any issues found with the window seals must be rectified before conducting the remaining steps
