Technical product information

| Topic | New Continental GT and GTC - Window drop glass concerns |

New Continental GT and GTC

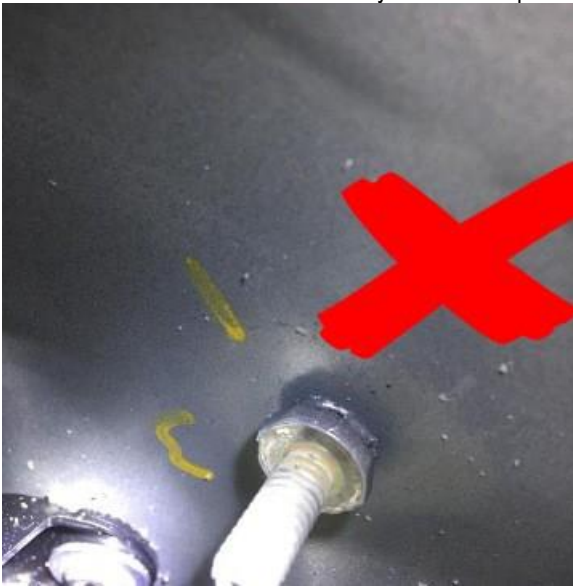
- Earth point 736 RHR and Earth point 738 LHR
- Check for cleanliness and security of both earth points Figure 2 shows an example of a contaminated earth point (dirt/paint/debris)

- Remove any dirt/paint/debris from the earth points using suitable abrasives/wire brush ensuring no damage is caused to the earth stud threads as shown in Figure 3

- Secure the earth point fixings to (9Nm)

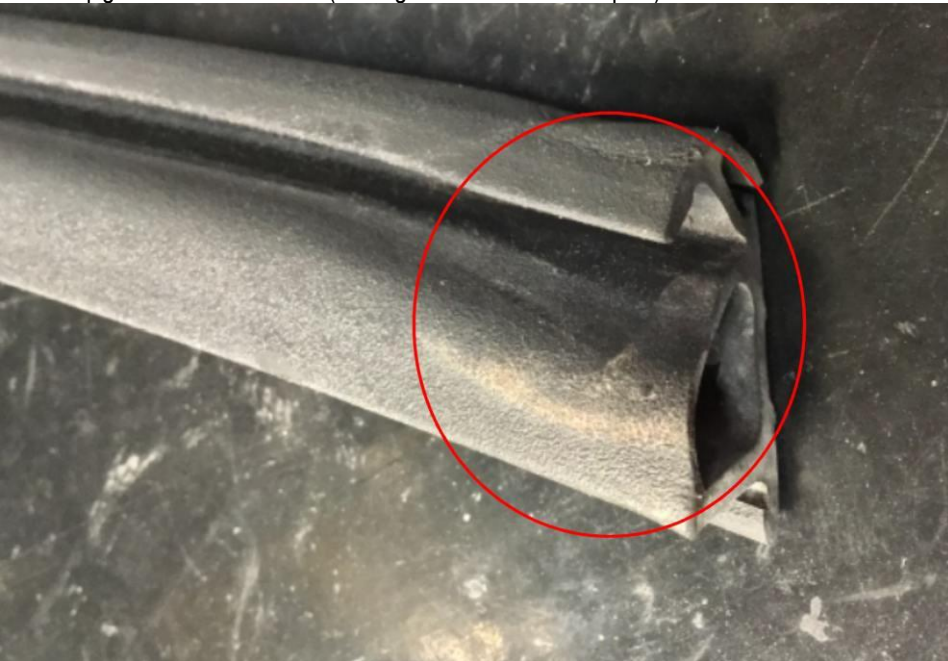
Figure 4

- Damage
- Splits
- Tears
- Misalignment
- Incorrectly fitted/located
- Drop glass seal deformation (see Figures 4 and 5 as examples)

NOTE: Any issues found with the window seals must be rectified before conducting the remaining steps
