Technical product information

Topic	New Continental GT, GTC, New Flying Spur - Blind spot monitors not functional DTC C1114F3 logged in address 003C or 00CF
Market area	Russische Föderation (5RU),Australia E04 Bentley rest Asia and Australia (6E04),China 796 VW Import Comp. Ltd (Vico), Beijing (6796),Germany E02 Bentley rest Europe (6E02),Japan E03 Bentley Japan (6E03),Korea, (South) E08 Bentley South Korea (6E08),United Arab Emirates E06 Bentley Middle East and Africa (6E06),United Kingdom E01 Bentley UK (6E01),United States E05 Bentley USA and rest America (6E05)
Brand	Bentley
Transaction No.	2062884/5
Level	EH
Status	Approval
Release date

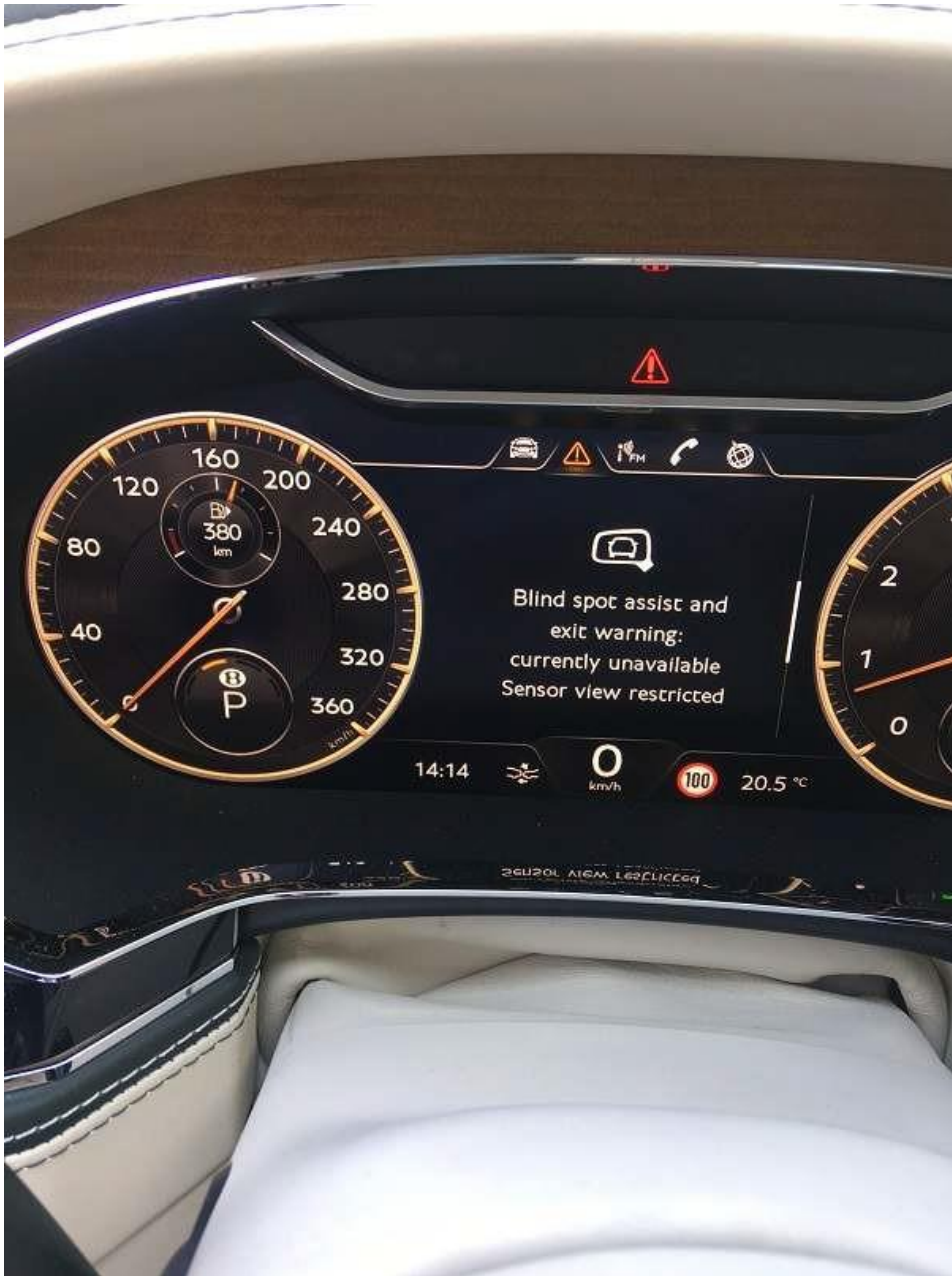
Figure 1

Blind spot monitors (Wing mirror illuminations) are not functional in conjunction with sporadic Bentley assist warnings present in the DIP (Figure 1)

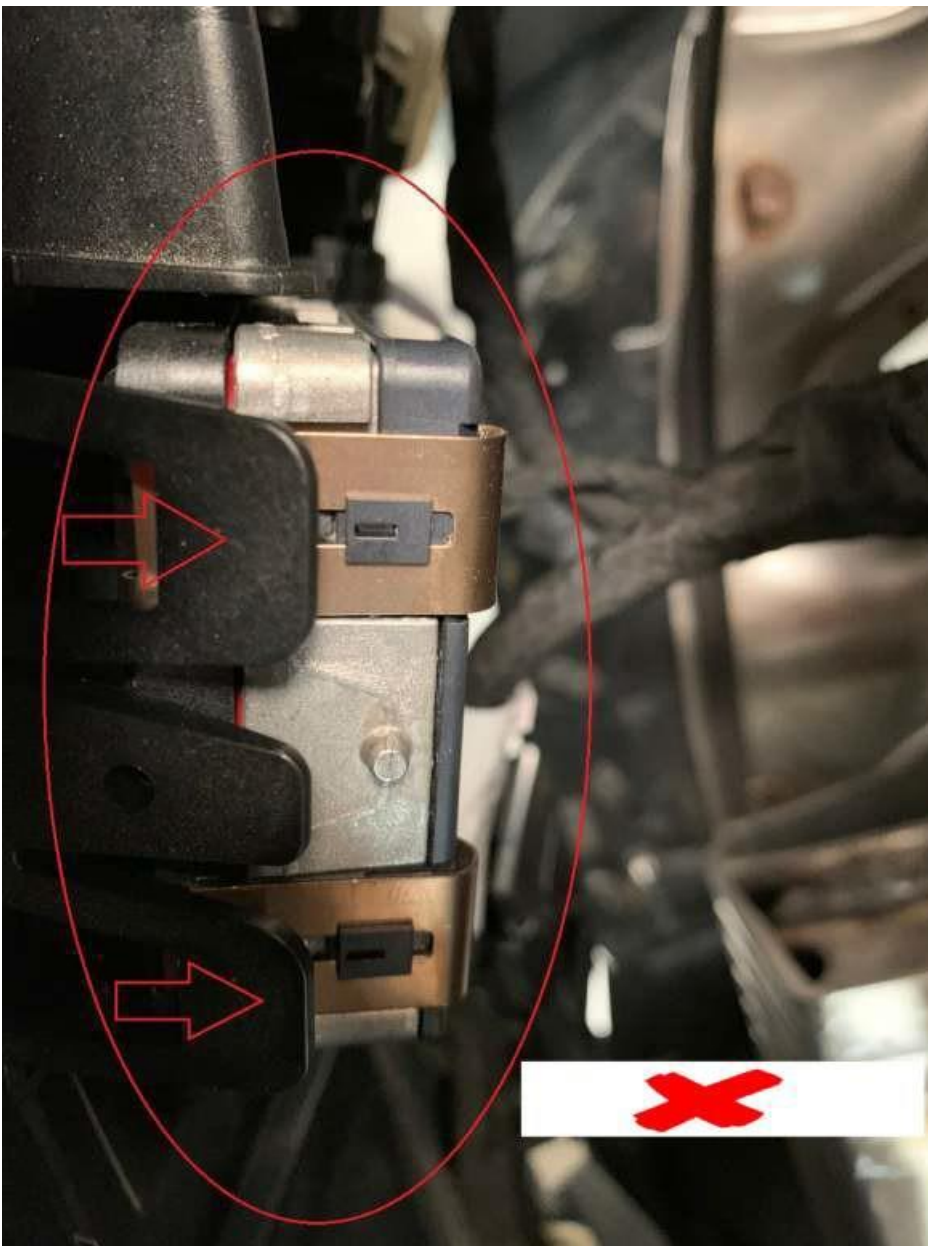
Figure 2

Master or slave rear radars are not fitted correctly (unclipped or poorly installed)

- 003C: Inspect the RHS rear radar fitment and/or bracket damage
- 00CF: Inspect the LHS rear radar fitment and/or bracket damage

3) In the event one or both control units are loose/detached - Refer to Figures 2 (Before adjustment) and 3 (After adjustment) and also reference Rep.Gr - 44 Lane change assist control units (J769 and J770) - To remove and fit
