Technical product information

| Topic | Engine intermittently fails to start/Kombi pop up 'Engine start system: fault' |

New Continental GT/GTC and Flying Spur

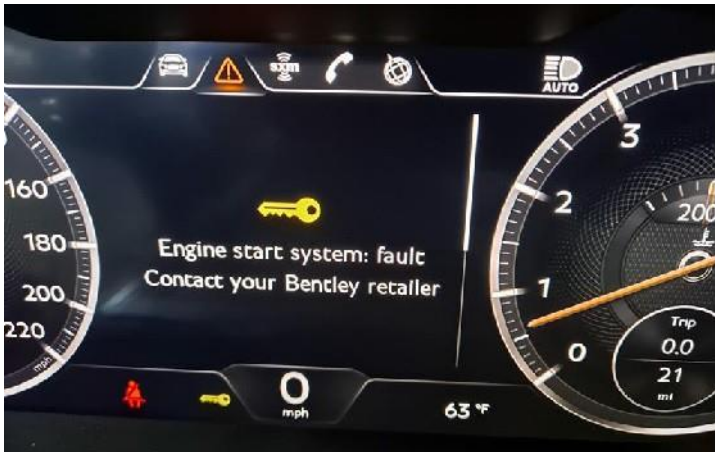
Engine starts but customer gets a pop up error on the Kombi

In the event the Kombi pop-up appears the following DTC will also be stored within address 46 -Convenience system central control unit B143C29: Access/start authorization button, Range/Performance
