Technical product information

Topic	Fluid leak from front air spring
Market area	Bentley; worldwide (2WBE)
Brand	Bentley
Transaction No.	2054635/7
Level	EH
Status	Approval
Release date

New Continental GT(C) and New Flying Spur

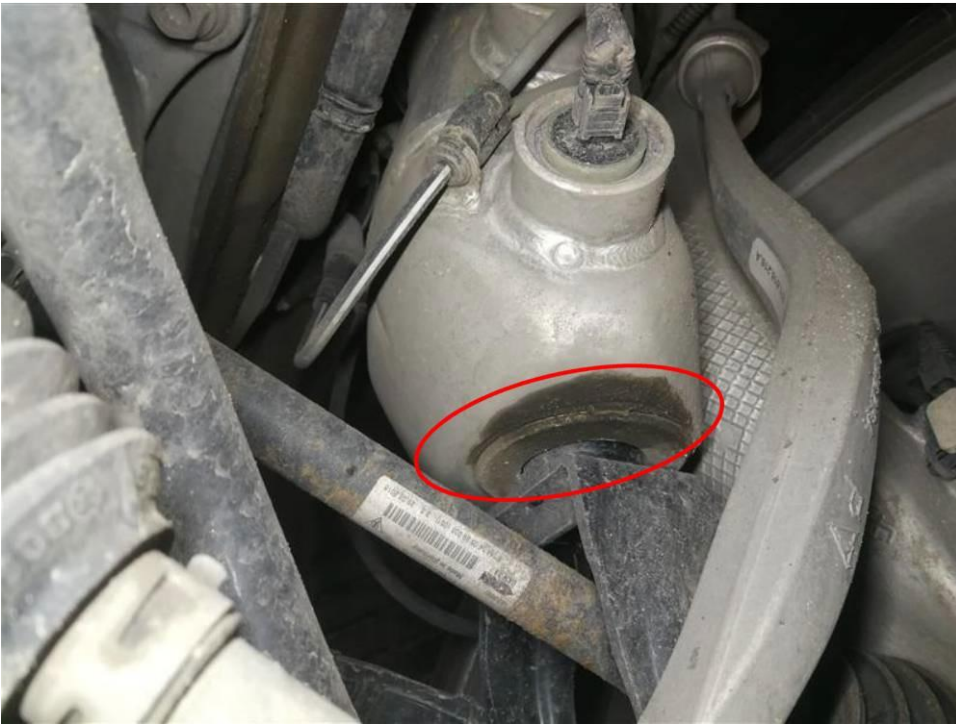
Figure 1

- Fluid leak from the base (Figure 1) and/or the top (Figure 2) of the front air spring/s

The fluid shown in Figures 1 and 2 is assembly fluid residue. The fluid is applied to various internal components of the air spring during manufacture.

1) Take a photograph of the applicable air spring in which the residue is evident

- Clean the residue from the air spring

2) Conduct a road test

3) On return from road test - Conduct a further inspection to check/confirm the residue is no longer evident

- Should the residue no longer be evident – No further action is required, parts must not be replaced for this concern
- Should the residue be evident on return from the road test – Raise a DISS query and await feedback before carrying out any further work
NOTE: Please ensure photographs of the residue are attached within the DISS query clearly showing the residue prior to cleaning/road test and post road test
